# Driftwood Bay RRS

## Facility History

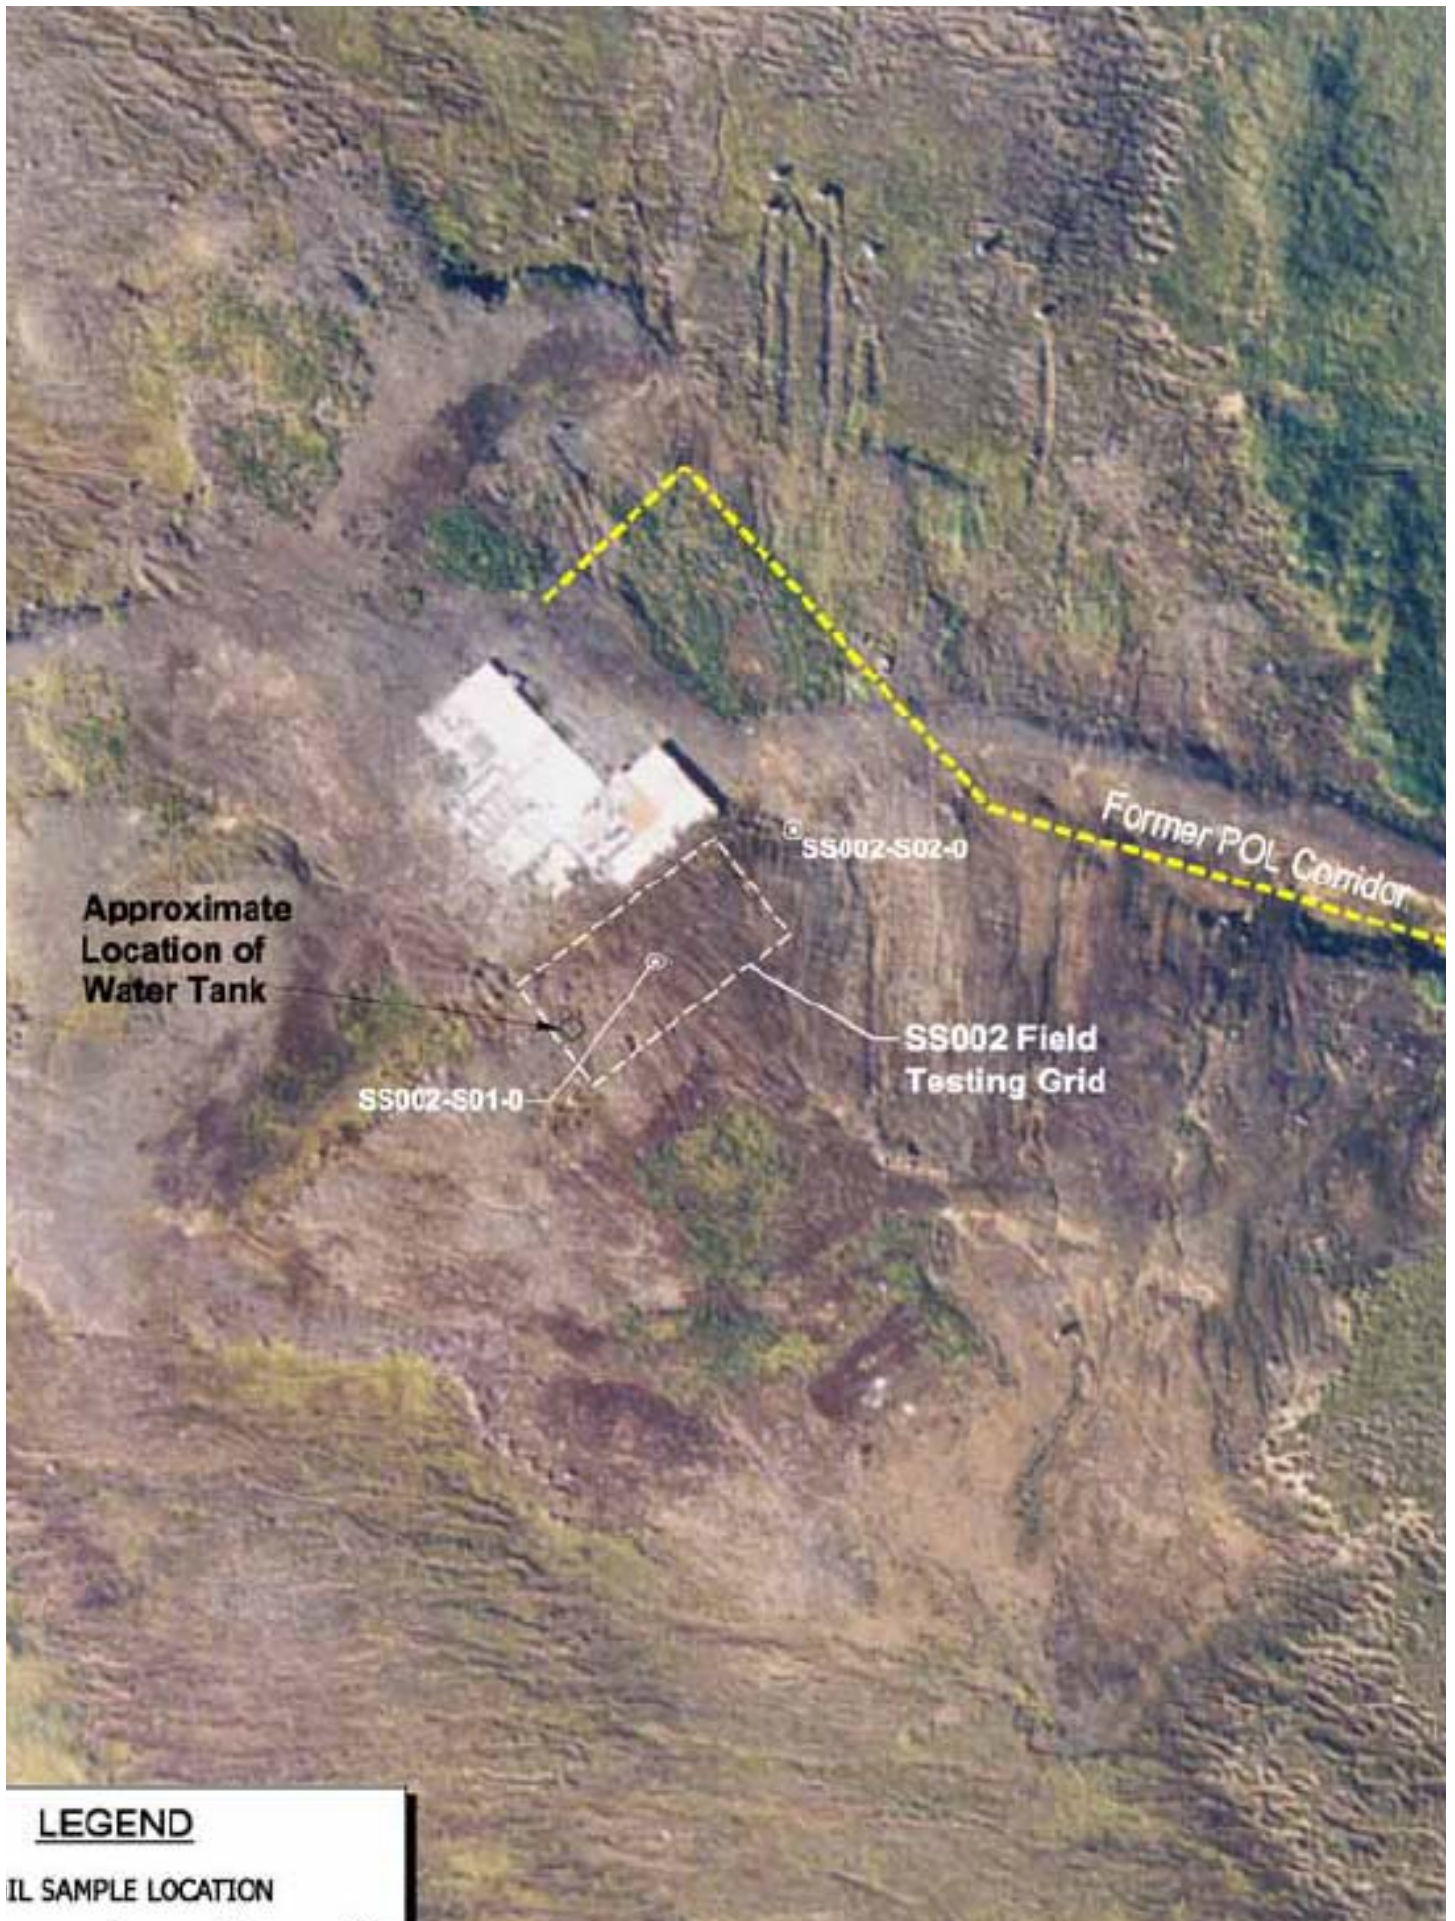
# SS002 – Landfill No. 1

- Landfill operated under permit
- Created under State solid waste regs after 1984, therefore not ERP eligible
- 1995 PA/SI – 1 sample collected near seepage
  - Total TPH = 16,000 mg/kg
  - DRO = 550 mg/kg
- 2000 Inspection found subsidence and surface debris
- PA/SI collected:
  - cover soil samples for field screening
  - 2 composite samples submitted for DRO/RRO, PCBs, Pest/Herbicide, metals
  - Concentrations below screening criteria

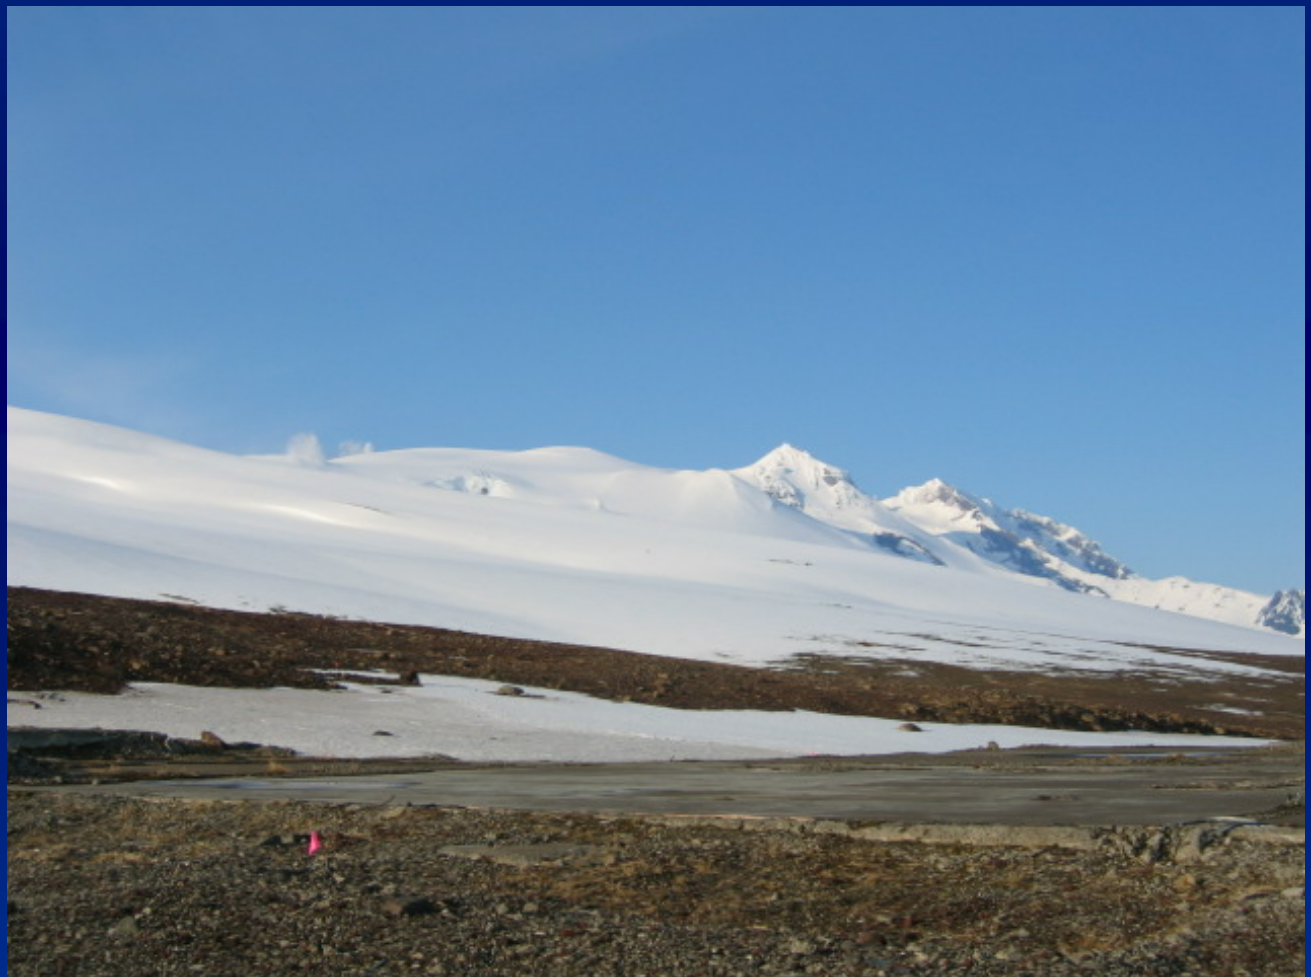
# The Former Composite Building Pad 0T001 (Looking Southeast)

- Former Building foundation, antenna pads, two former 20,000 gal USTs, 110 gal AST
- 1985 USACE site inspection – 7 surface soil samples
  - PCBs max 6.8 mg/kg NW corner of building,
  - DRO max 1,100 – location not known
  - VOCs detected
- 1991- All structures demoed, only one tank noted as removed
- 1995 PA/SI – 8 surface soil samples near building and antenna pads
  - PCB ND – not coincide with 1985 locations
  - DRO 1,300 mg/kg near 110 gal tank – may not be diesel

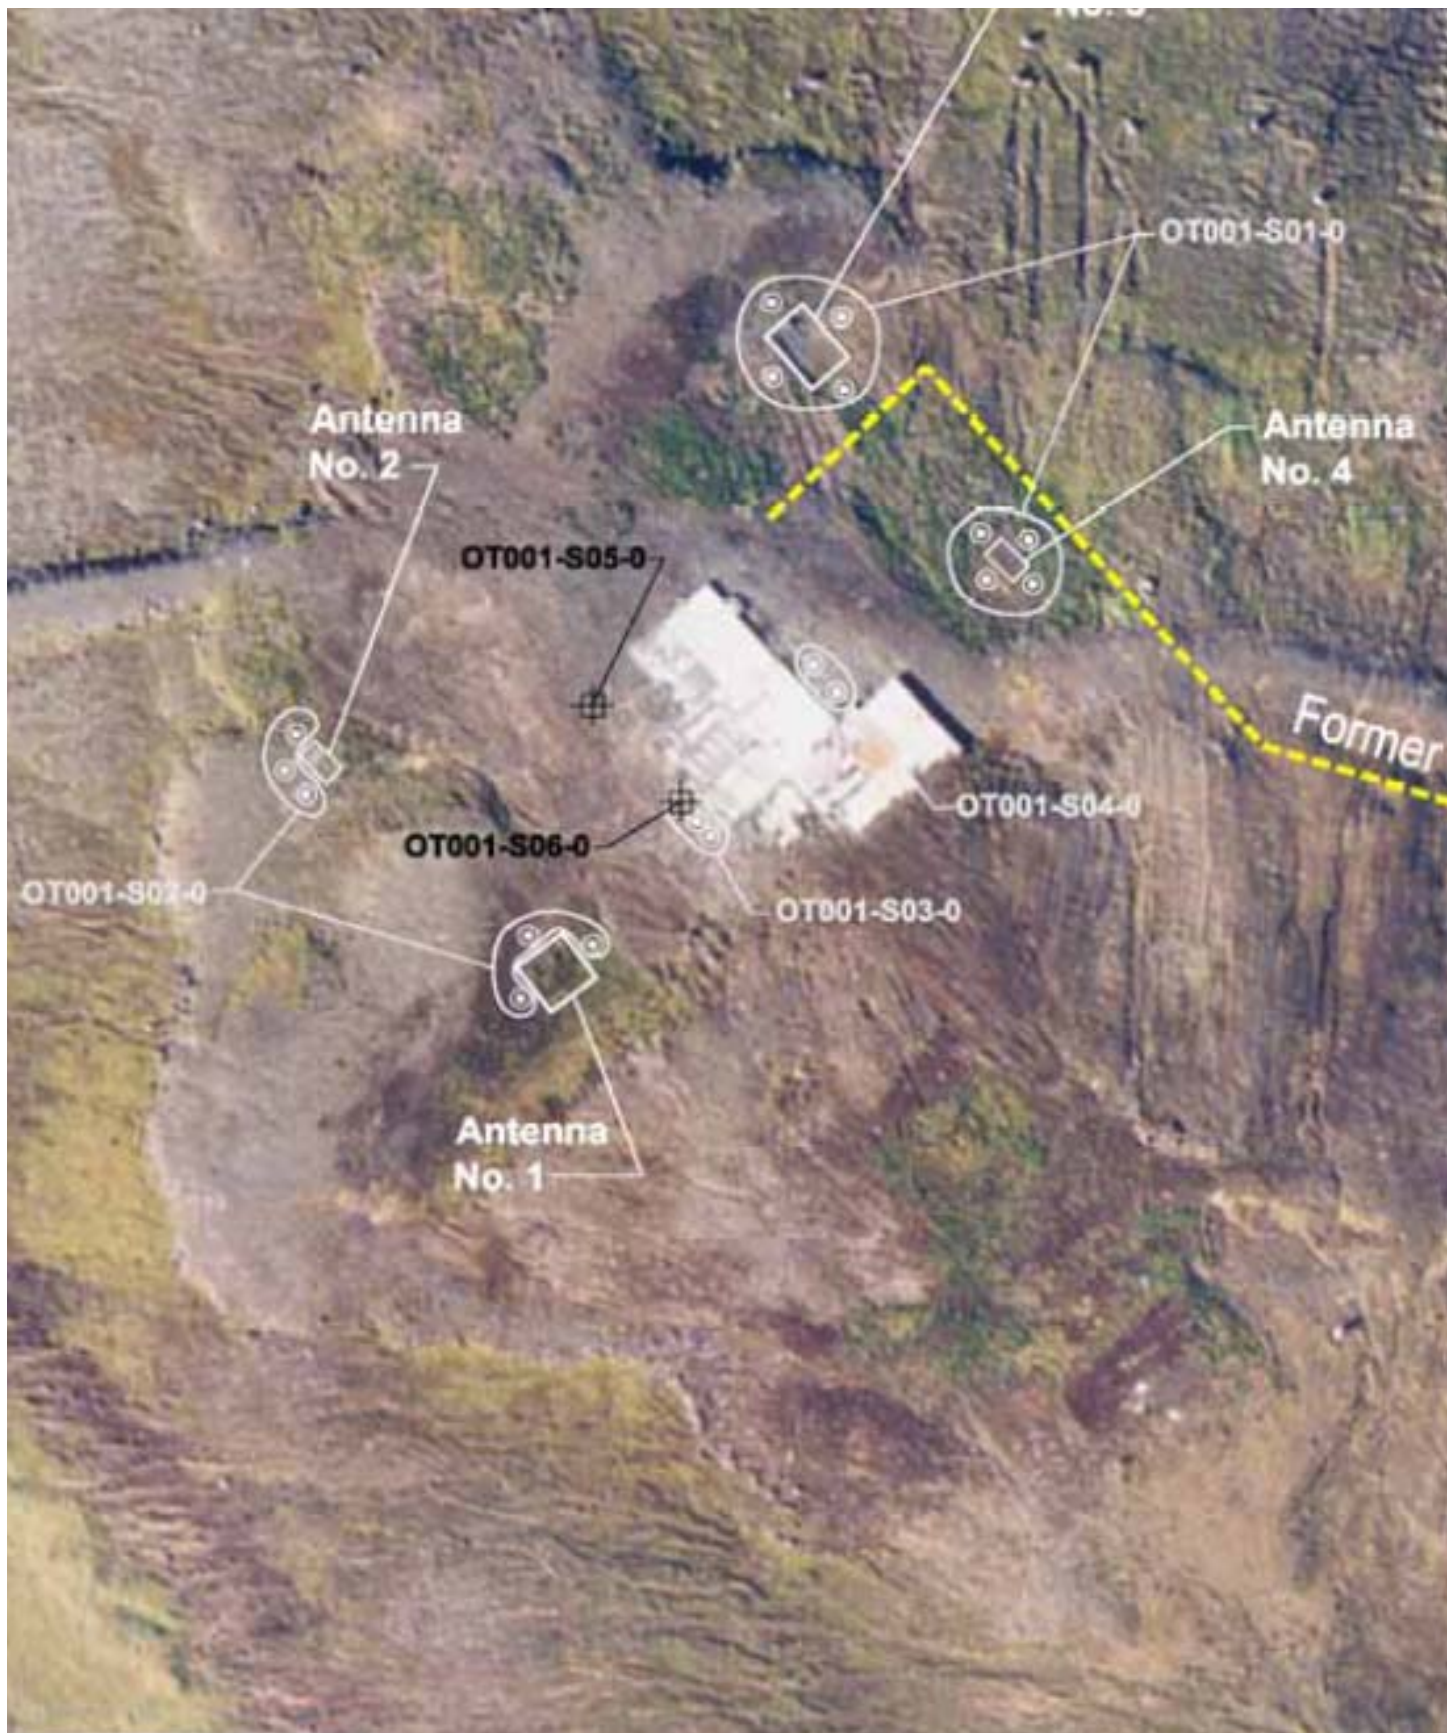
Location	DRO in ppm
OT001-S01	Composite from around Antennas 3 and 4	244
OT001-S02	Composite from around Antennas 1 and 2	770
OT001-S03	Comp along west side (PID and odor)	3030
OT001-S04	Comp along west side (highest CL hit)	307
OT001-S05	Test pit at former USTs	662
OT001-S06	Test pit at elevated PID hit	168

- PCBs not detected above reporting limit
- VOCS, GRO - ?

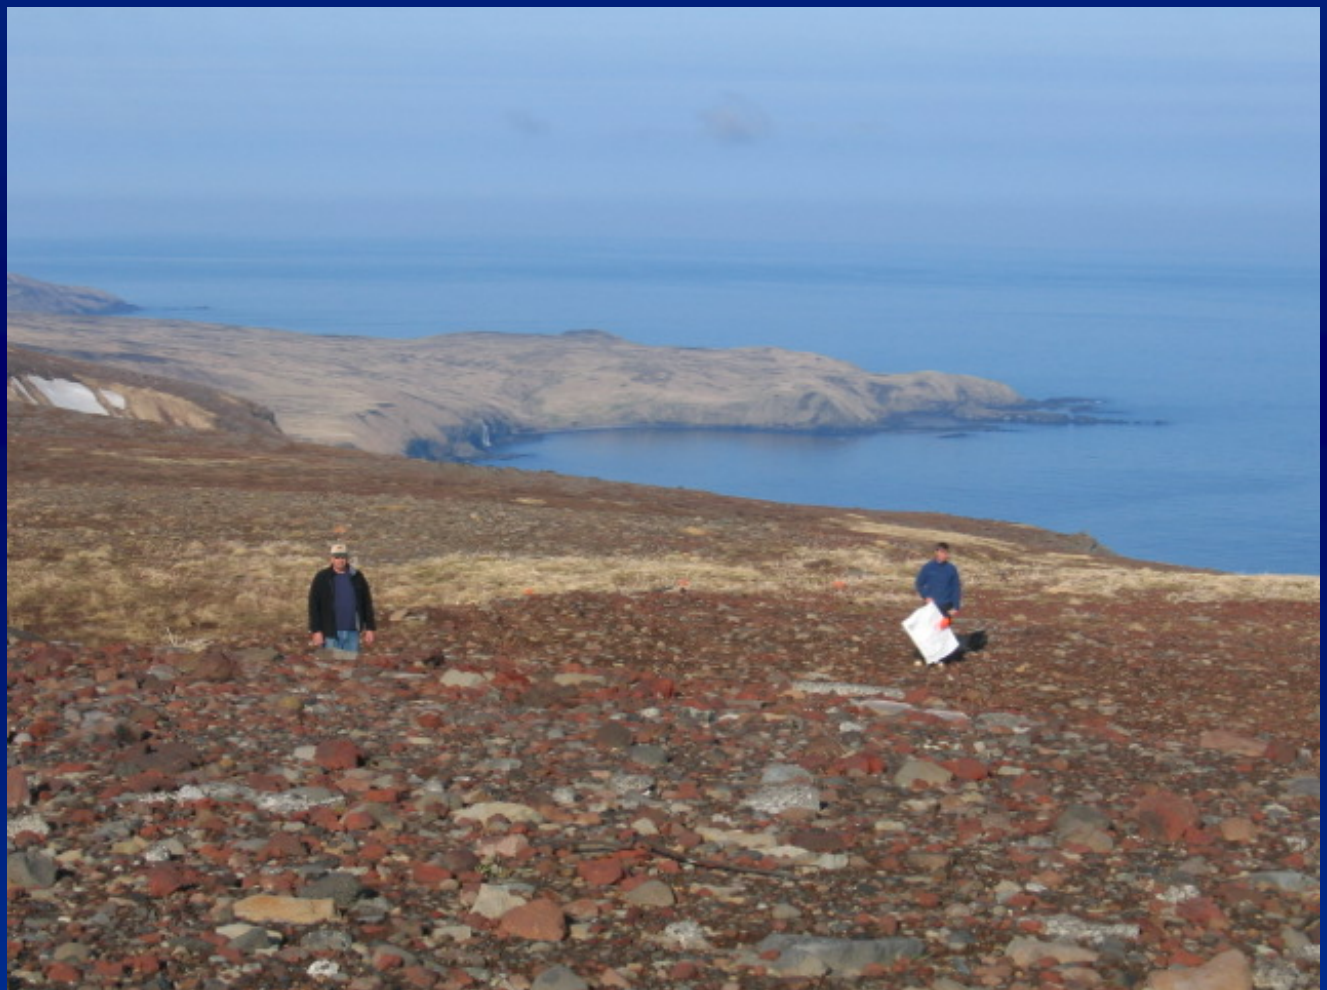
# WP003 (Looking Southwest)

- Floor drain outfall 250' NE of composite building
- 1985 USACE site inspection – 1 surface soil sample from end of drain within outfall
  - Trace BTEX, solvents, PCBs noted
  - 1991- All structures demoed, only one tank noted as removed
- 1995 PA/SI – 1 surface soil sample 60' downslope from outfall
  - TPH 120,000 mg/kg
  - GRO 609 mg/kg
  - DRO 75,000 mg/kg
  - Trace BTEX, pesticide

- End of pipe located 213' E of NE corner of composite building. Heavily stained soil noted up to 50' from outfall
- 15-20' diameter area of burned batteries noted 275 N of NE corner of building
- Two PID hits (9.5 and 34.4 ppmv) noted along west side of building
- Dexsil screening all below 25 ppm (1.33 - 3.42)

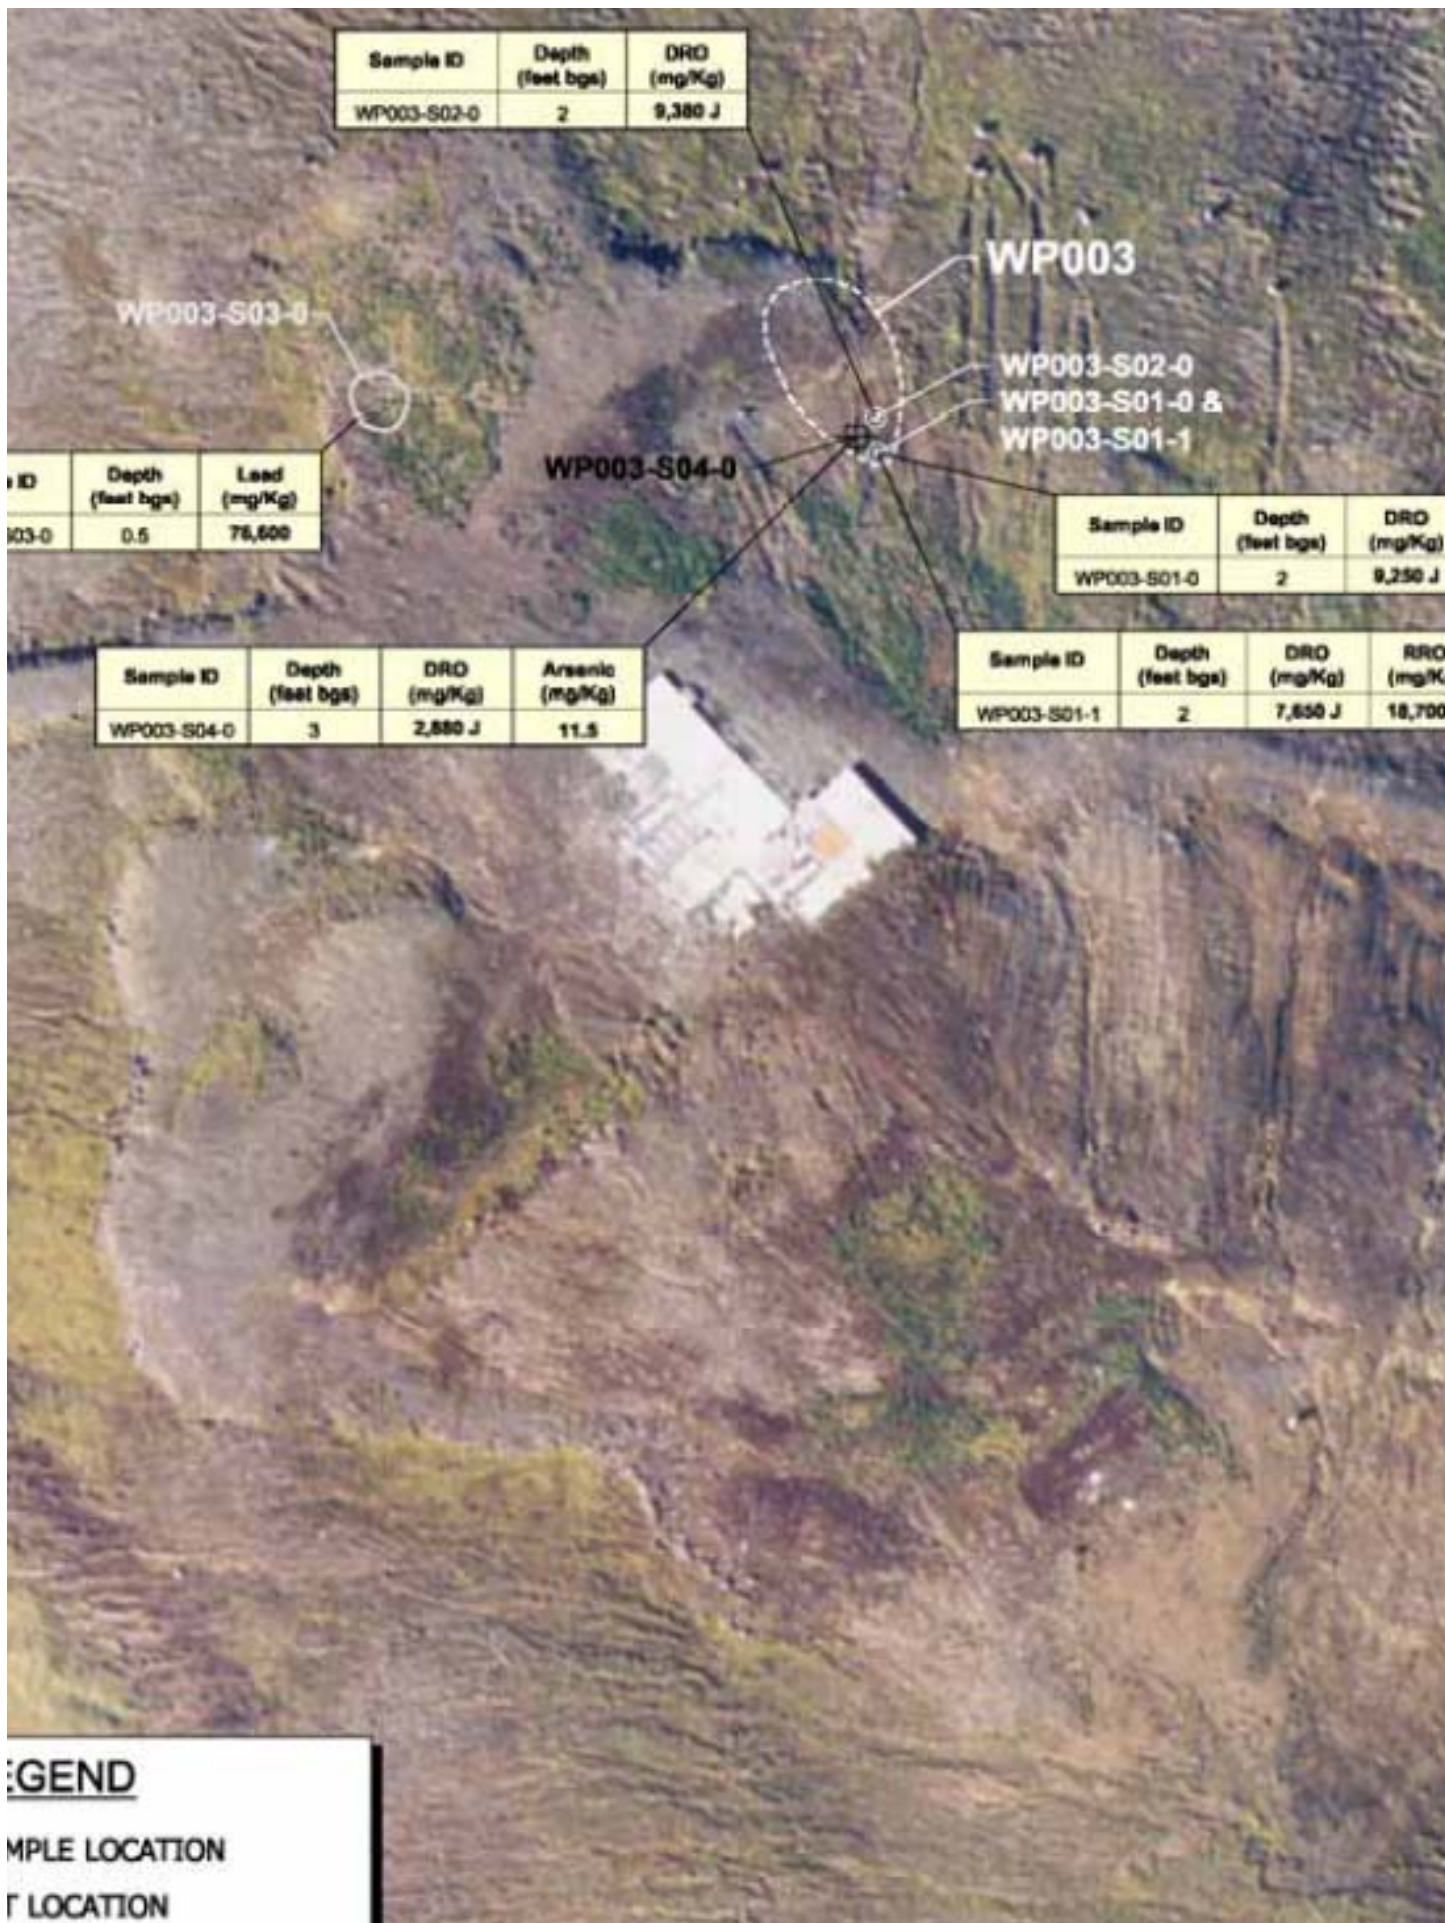
Location	DRO	RRO	Lead	As
WP003-S01	Outfall (2' bgs)	9250	29,800	4.45	4.94
WP003-S02	15' from outfall (2' bgs)	9380	18,700	3.78	9.22
WP003-S03	Composite from battery area (0.5' bgs)	98.5	506	76,600	3.76
WP003-S04	5' NW of outfall (3.5' bgs)	2880	337	5.8	11.5

- PCBs note detected above reporting limit
- VOCS, GRO - ?

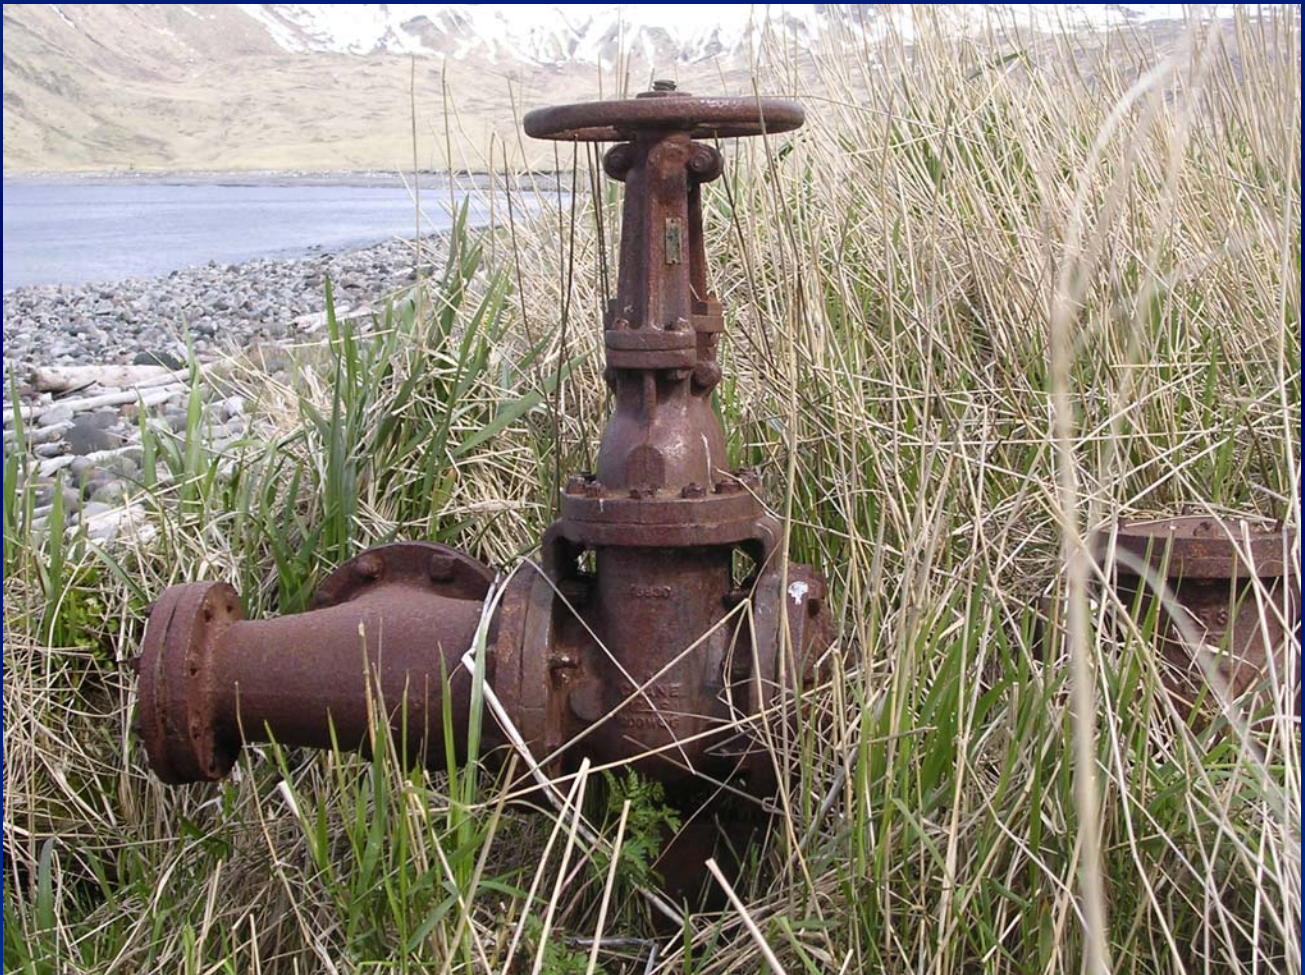
# SS008 POL Pipeline

- 4" diameter fuel supply line originating at fill stand on beach to pumphouse with 250,000 AST. From there, a 2" diameter pipeline was used to pump fuel to the composite building
- 1991 –removal of all above ground piping, POL removed and pipe placed in Landfill No. 1
- 1995 PA/SI – 3 surface soil samples from near north end of runway. One sample contained DRO 5,360 mg/kg.

- Portions of pipe found in place along beach and west of beach. No residual produce observed
- Fill stand found
- No evidence of stressed vegetation along corridor
- Only two PID hits noted along beach
  - Under fill stand (3.1 ppmv)
  - 700' east of fill stand (28.2 ppmv)

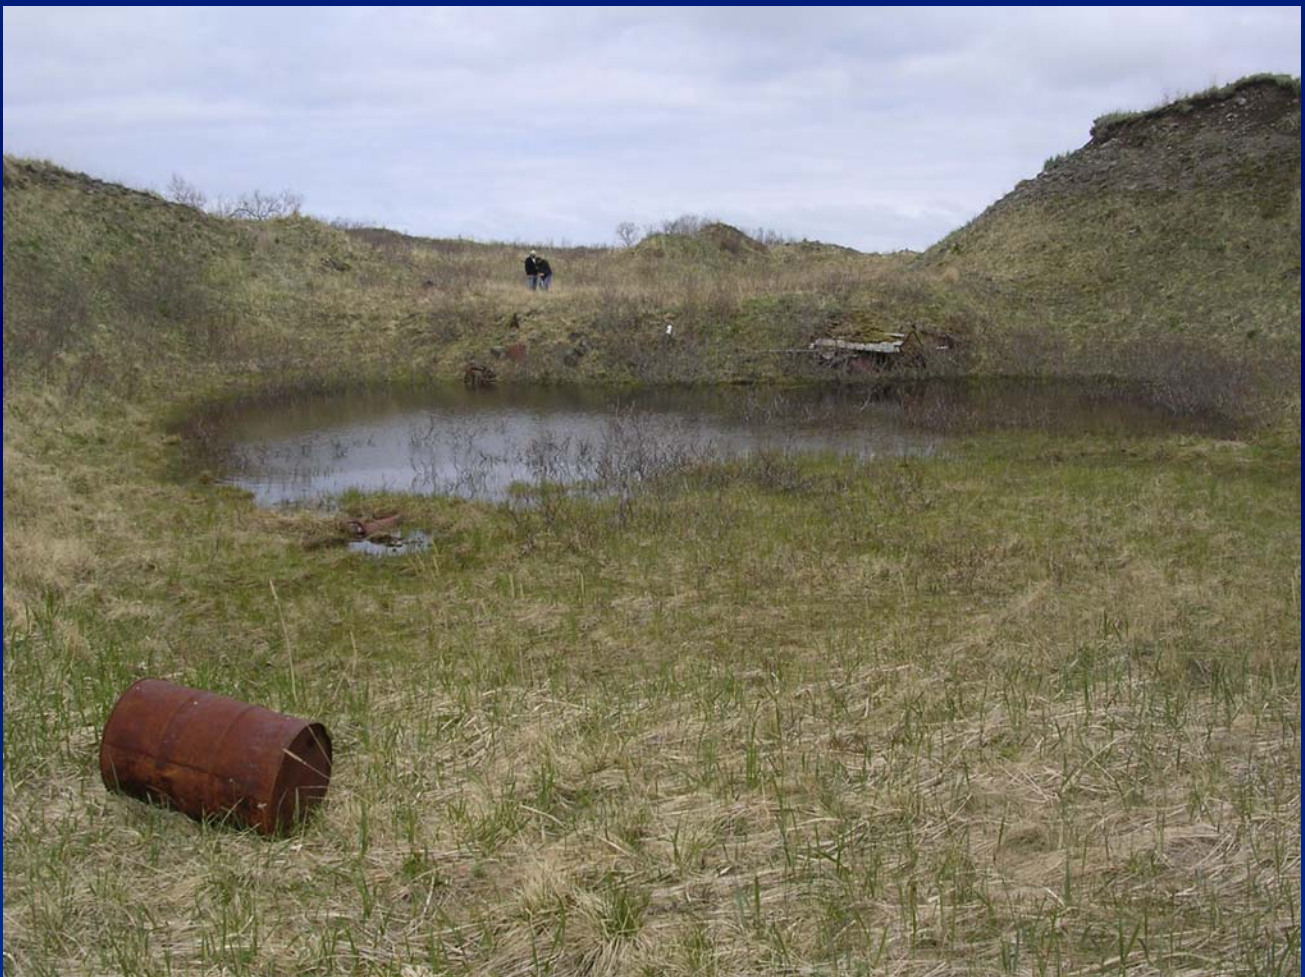
## The Old Disposal Area (Looking West)

- Landfill 1 mile S of runway - extent unknown. Anecdotal evidence that fluid from heavy equipment buried here.
- 1995 PA/SI – samples collected E of landfill
  - 1 surface soil sample- TPH and DRO below screening criteria.
  - 1 surface water sample –ND

- 18 55-gallons drums observed from air
- Appeared to be a borrow pit used as a Landfill (200' x 75', 20' deep)
- Small pond contained submerged drums
- Exposed debris included engine, vehicle parts, batteries, fire extinguisher
- No stressed vegetation, or sheen on water observed

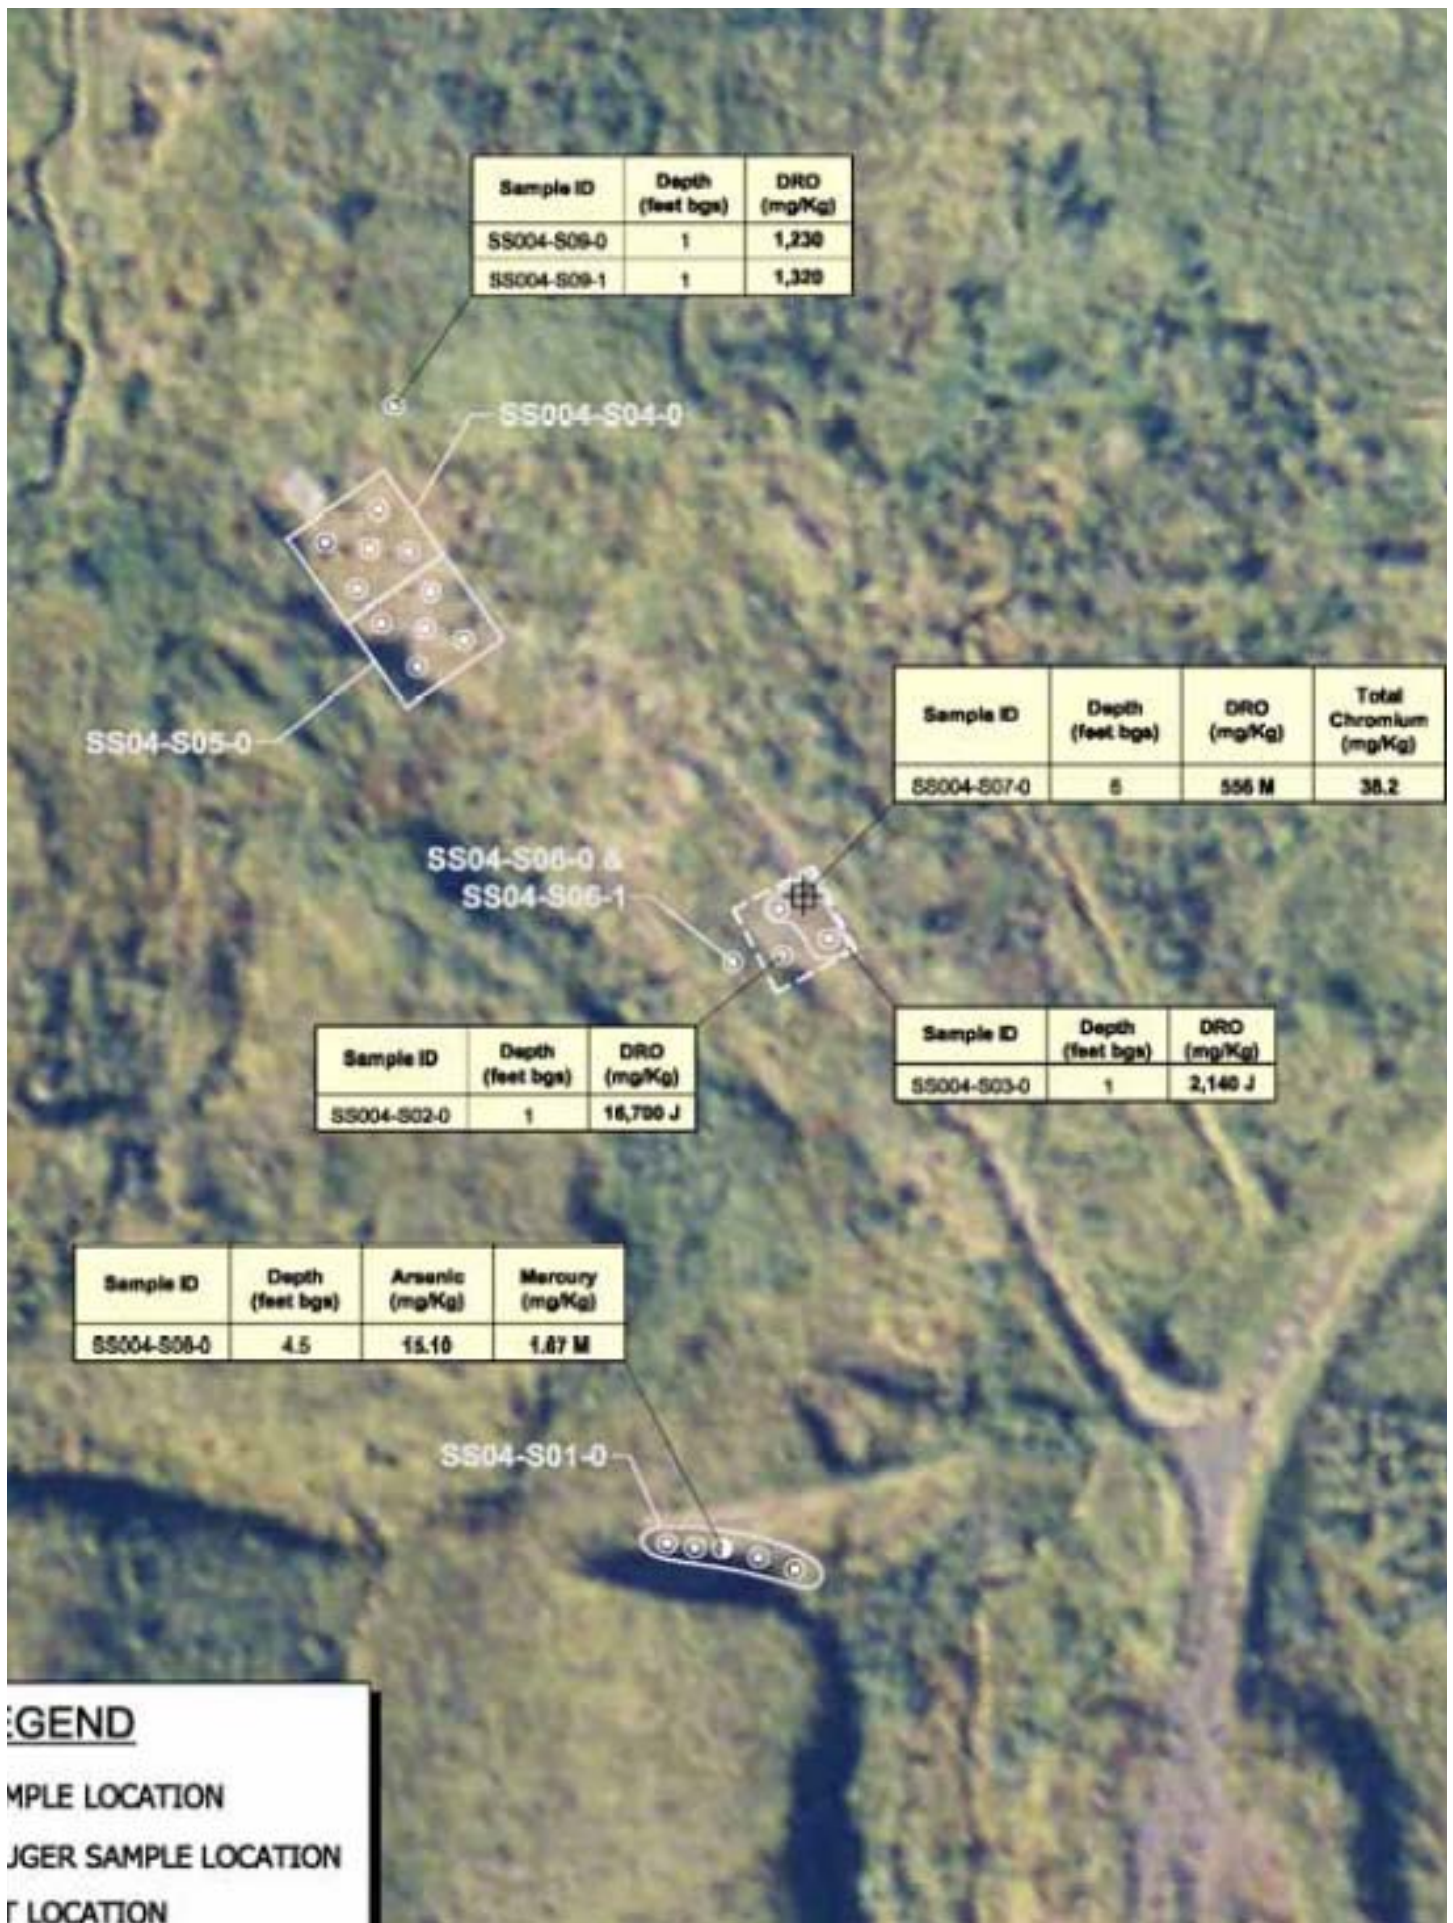
Location	DRO in ppm	Cr in ppm
SS004-S02	Highest PID hit	16,700	2.34
SS004-S03	Comp from highest CL hit	2,140	5.34
SS004-S07	W of highest CL hit	556	38.2

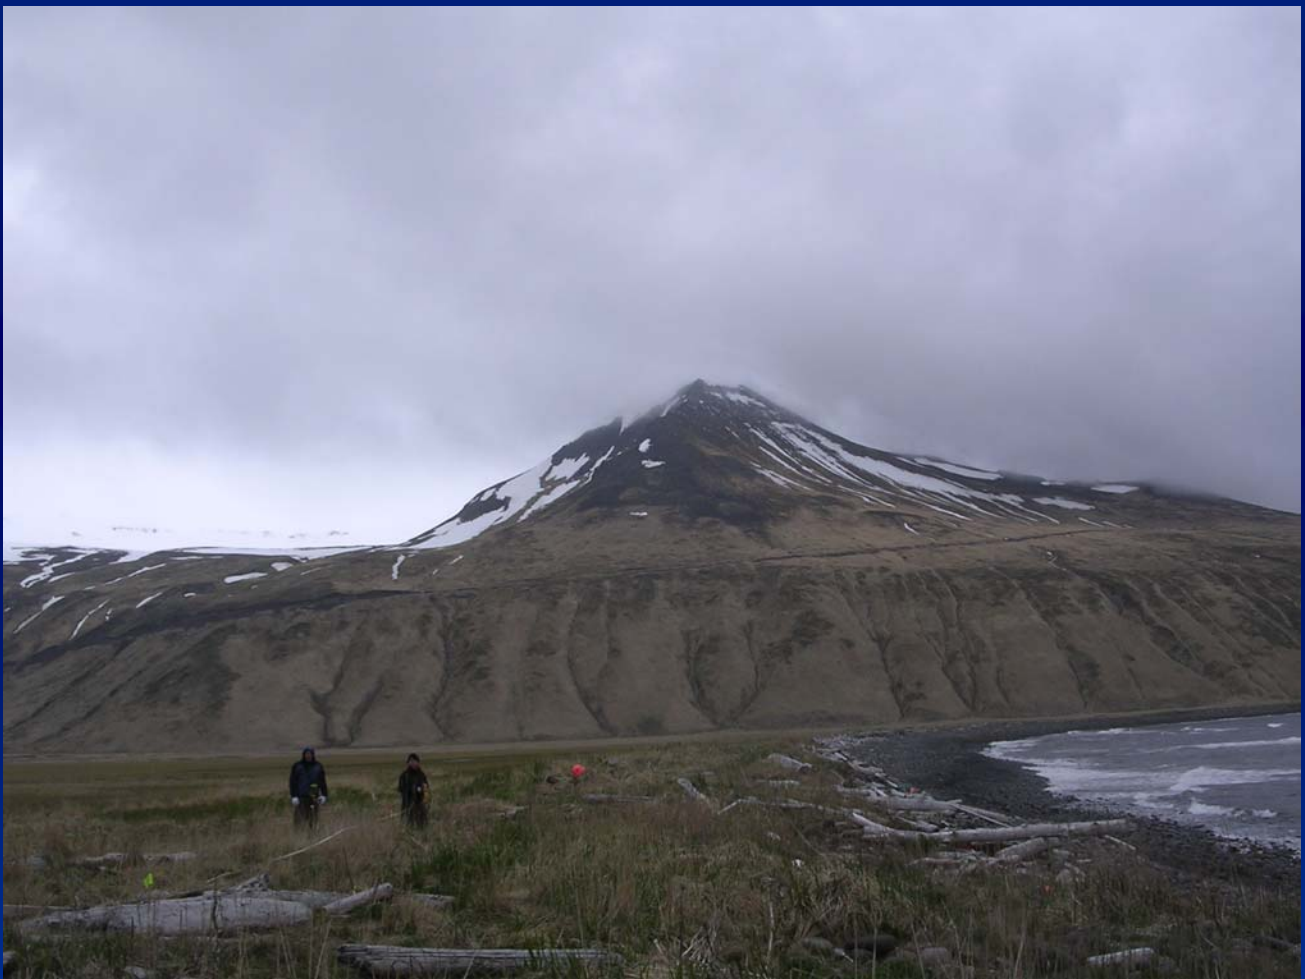
# SS007 Spill/Leak No. 7 at POL Tank Area (Looking South)

- Tank area 3,000' E of North end of runway
- 2 250,000 gal ASTs, 25,000 Mogas AST
- 1985 – 2 soil samples collected near 250,000 gal tanks. PCBs not detected. Surface water sample from Humpy creek – no metals detected
- 1991 – oiled sand excavated from foundations and placed in Landfill No. 1. Sample from sand – TPH/DRO = 27,000 ppm/1,930 ppm.
- 1995 PA/SI –
  - 3 soil sample collected - from both foundations, north side of pumphouse E of landfill – DRO near foundation max = 9,700 ppm, near pumphouse = 13,300 ppm
  - 1 surface soil sample- TPH and DRO below screening criteria.
  - 1 surface water sample from Creek – DRO, BTEX ND

- Foundations for 250,000 gal tanks found.
- Pumphouse foundation located
- Earthen berms found surrounding tank farm
- No beach landing found due to wave action
- MOGAS tank location not found – may have been reworked by wave action

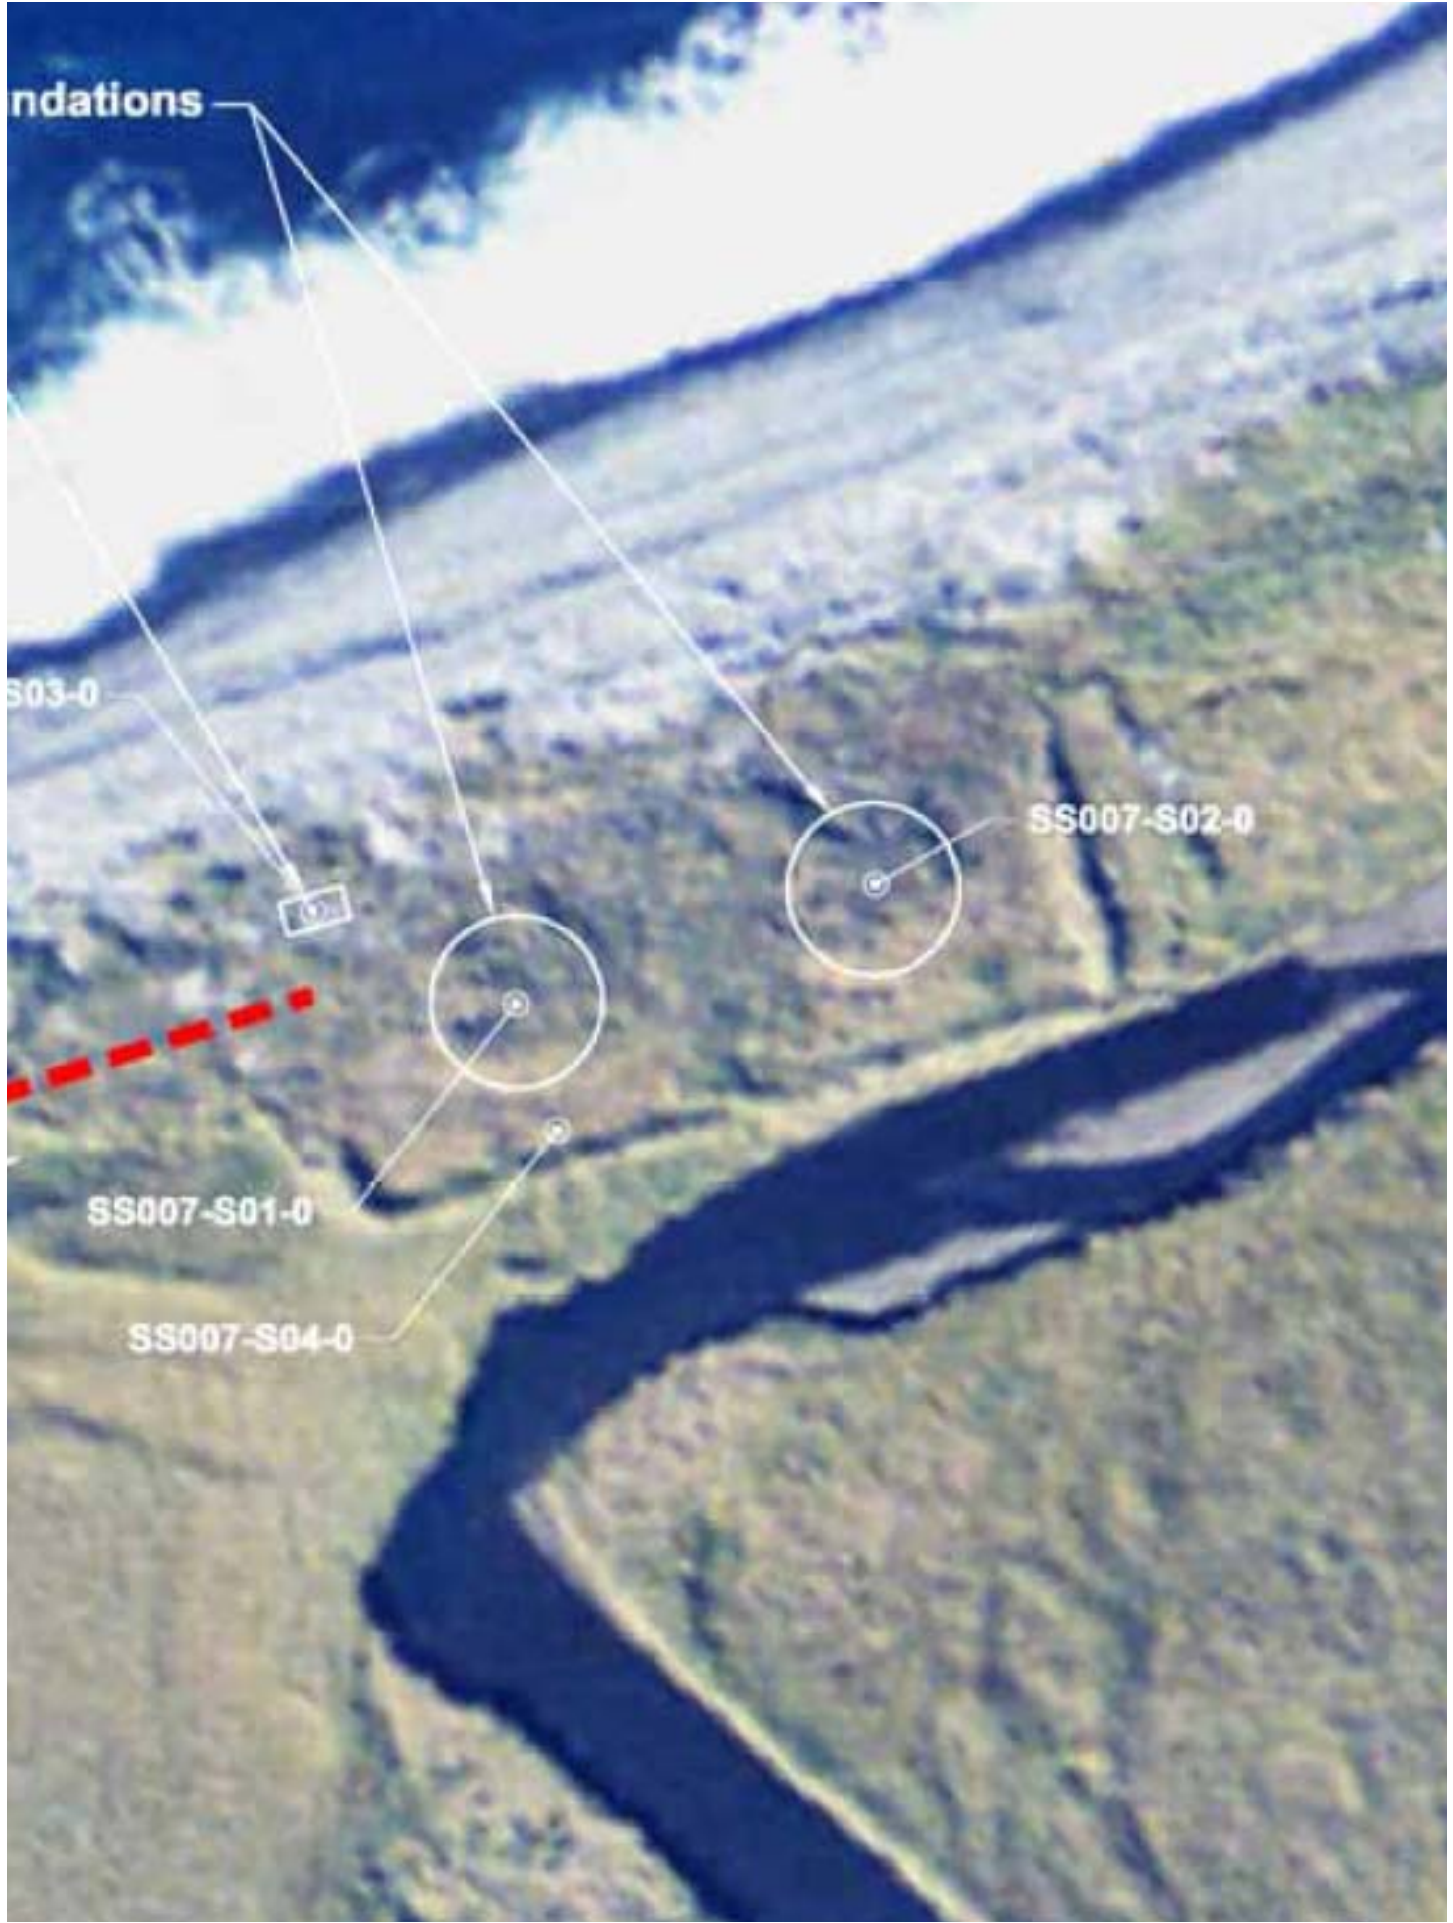
Location	DRO in ppm	Benzo(a)pyrene in ppm
SS007-S01	W pad	72.8	NA
SS007-S02	E pad	3,900	NA
SS007-S03	4' N of pumphouse	13,700	2.37
SS007-S04	Highest PID hit	37.4	0.0788
