# Driftwood Bay RRS

## Facility History

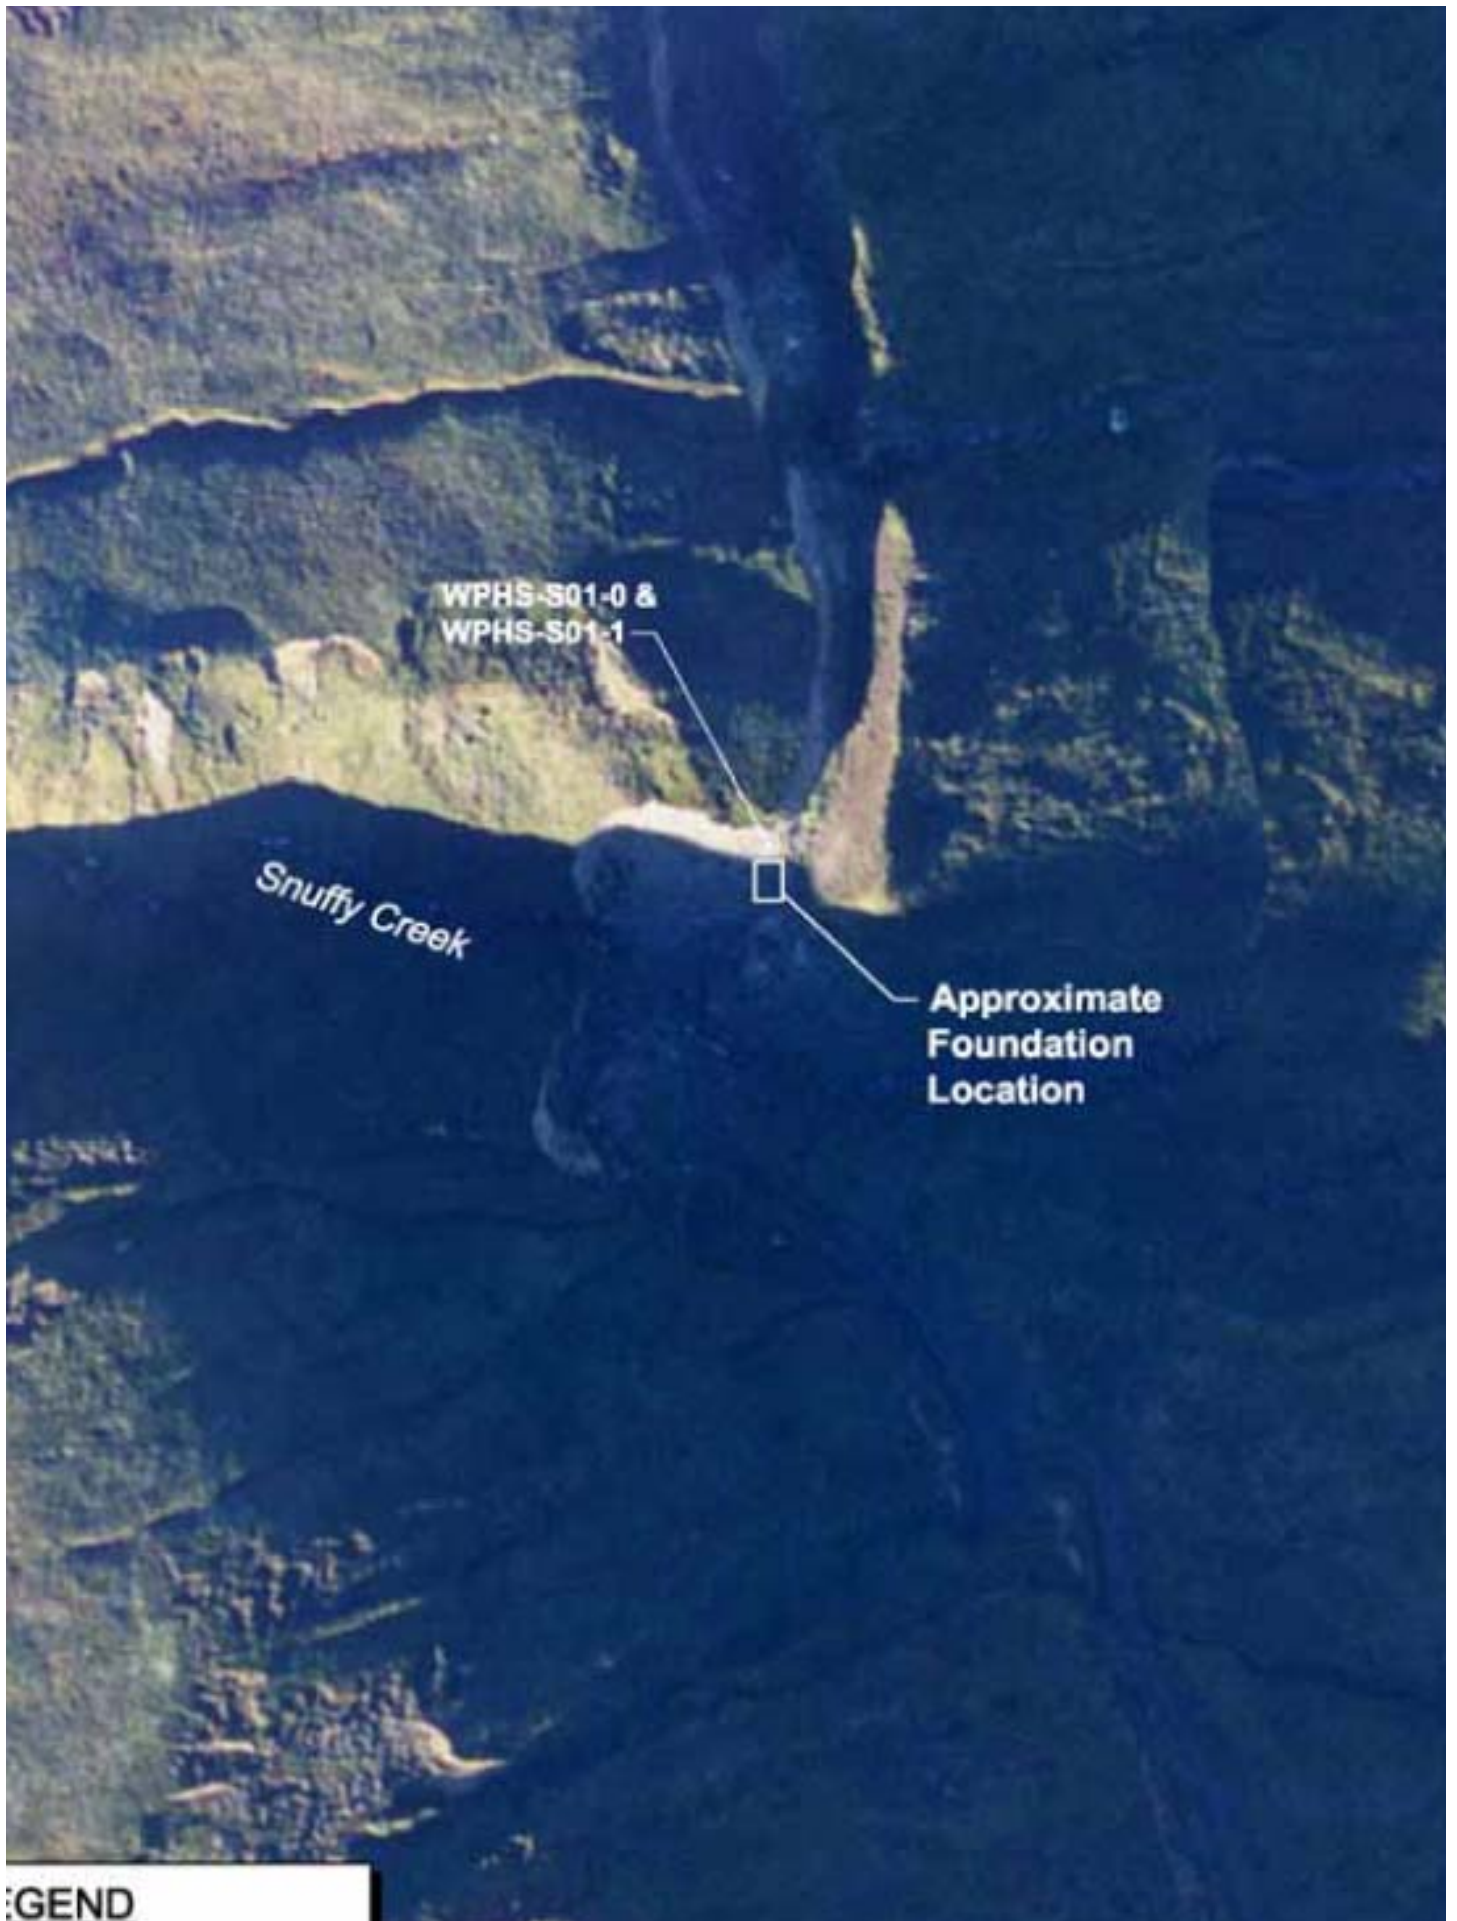
- UST appears to be in place but surrounding soil could not be removed due to safety concerns.
- DRO detected at 7,570 ppm.

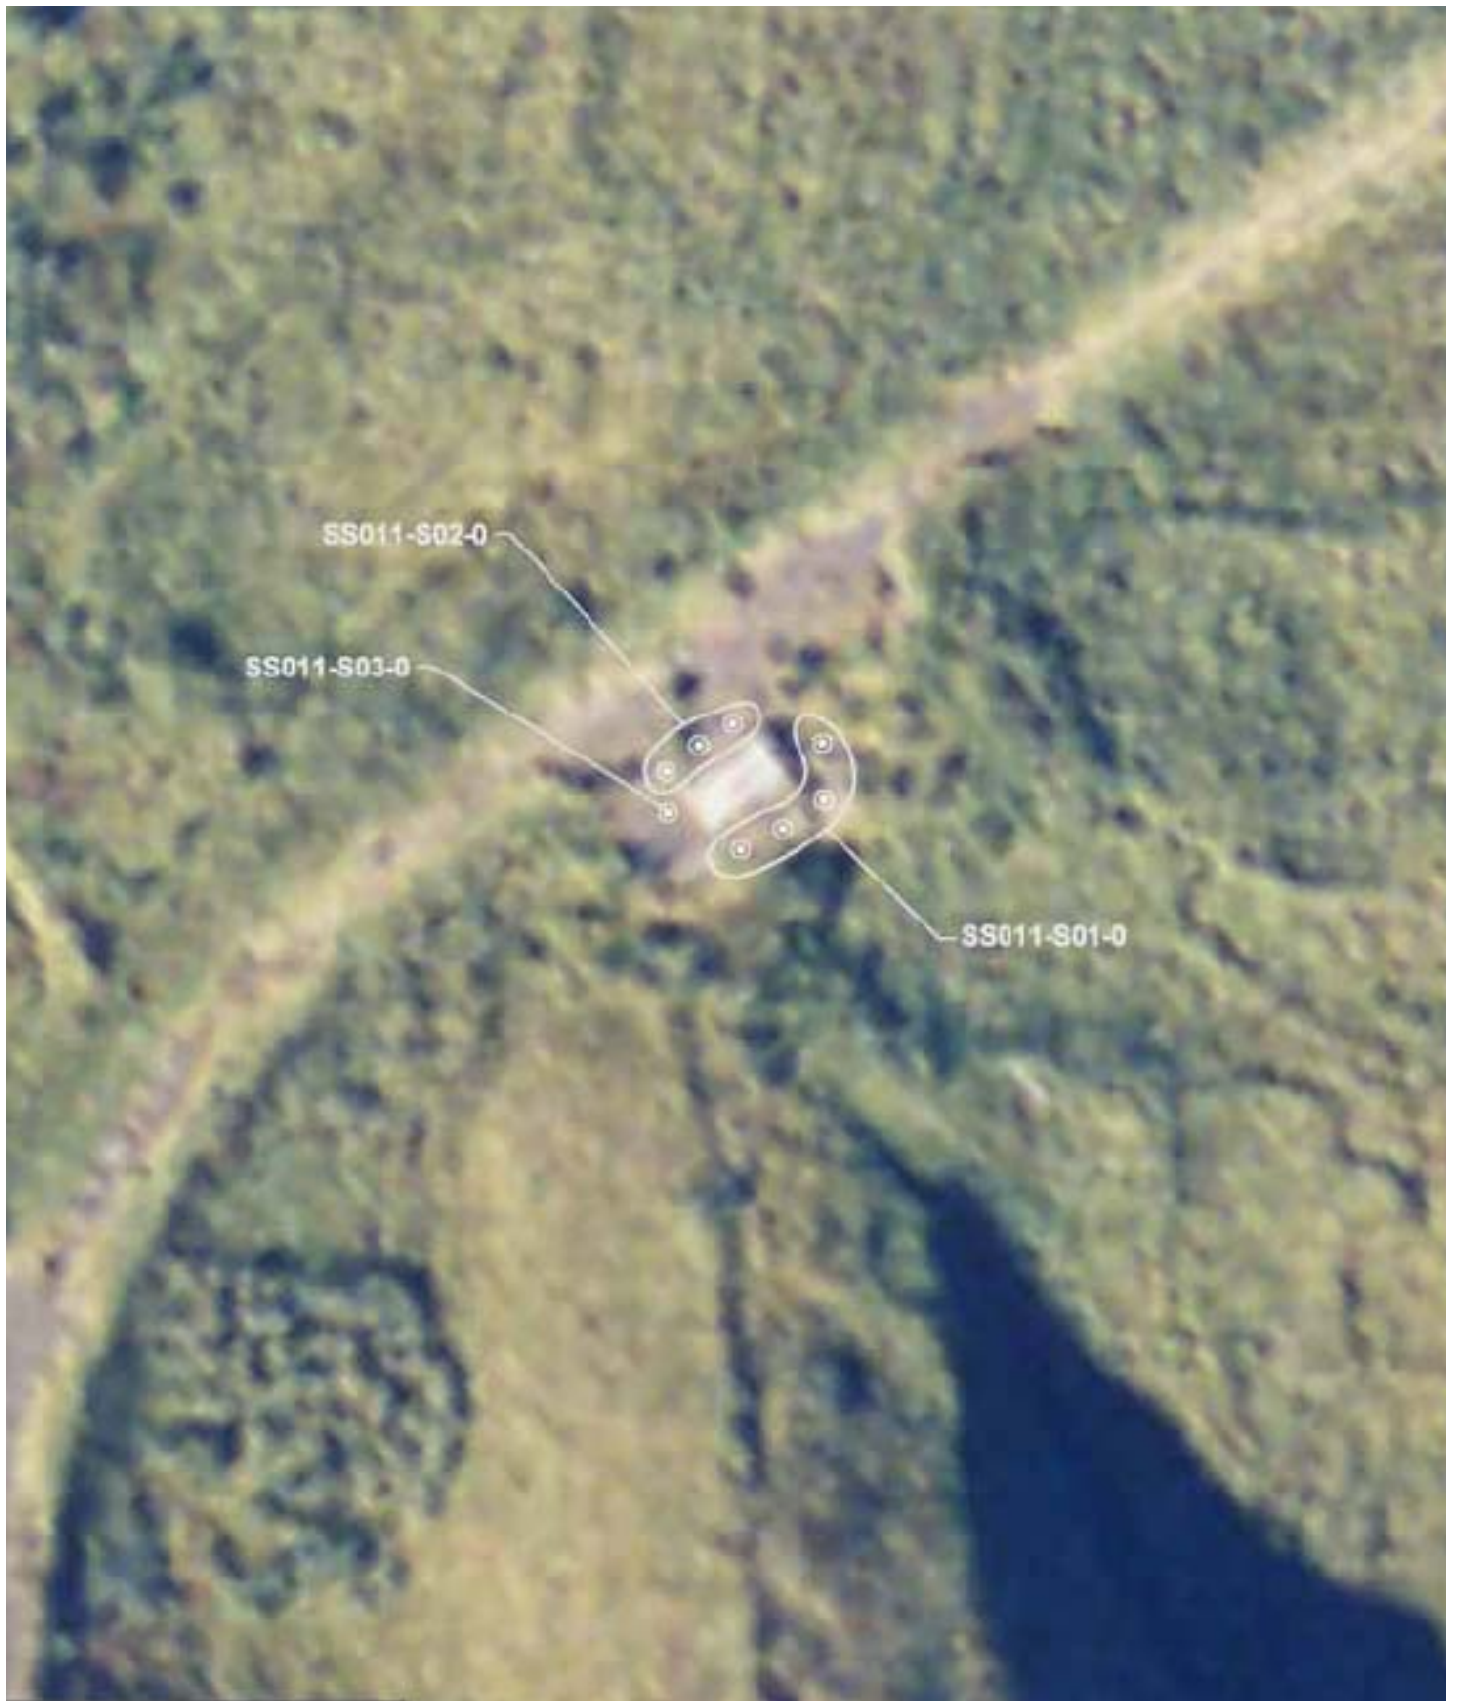
- Foundation of vault found in place 10 x 15'.
- Low levels of DRO detected (3.67 – 887 ppm).
