Conference on Accelerating Site Closeout, Improving Performance, and Reducing Costs Through Optimization

Accelerated VOC Source Investigation Pairing SCAPS/MIP with EPA Triad, Marine Corps Base Camp Pendleton, California

Karen Collins, San Diego Navy Public Works Center

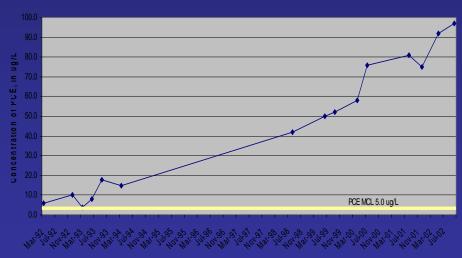
Figure 2-1. Water Quality Hydrograph, PCE in 9W-07A Groundwater IR Site 9 MCB Camp Pendleton, California

- Site 1114 identified in 2003 because PCE concentrations in well at adjacent site increased from 4 ug/L to 97 ug/L between 1993 when LTM ROD was signed and 2002
- MW 9W-07A is a cross-gradient perimeter well for Site 9, the former Waste Stabilization Pond

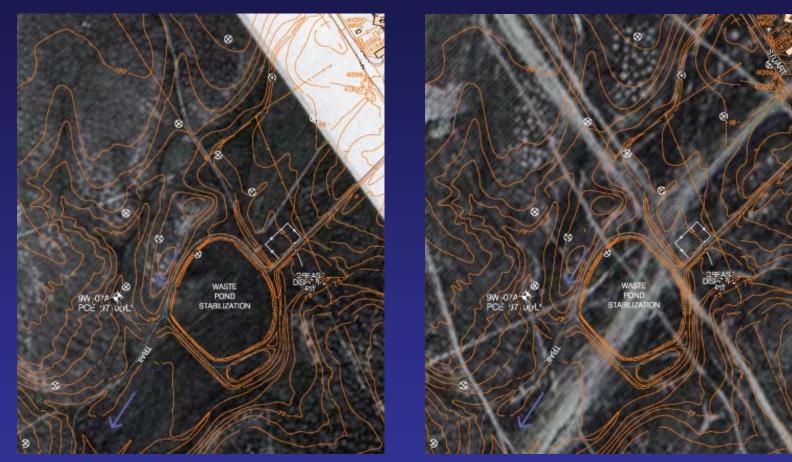
Phase I – Preliminary Assessment 1932 1953

• No history of industrial operations southwest of Stuart Mesa Road.

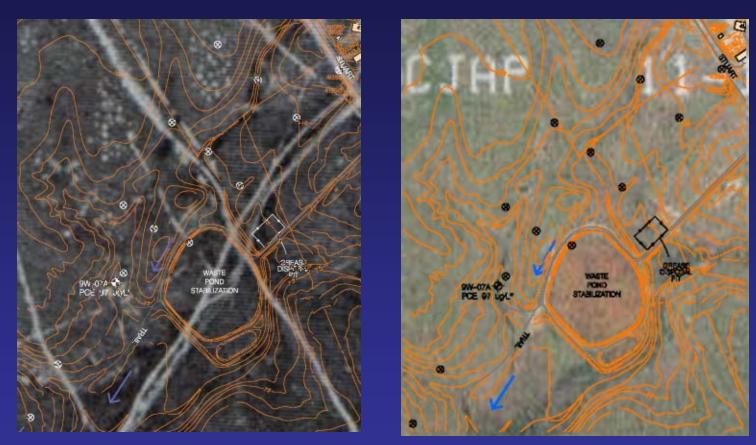
Phase I – Preliminary Assessment 1958 1993

Development NE of road consists of barracks, NEX, fire \bullet station, medical/dental clinic, mess hall, training facilities, equipment storage areas.

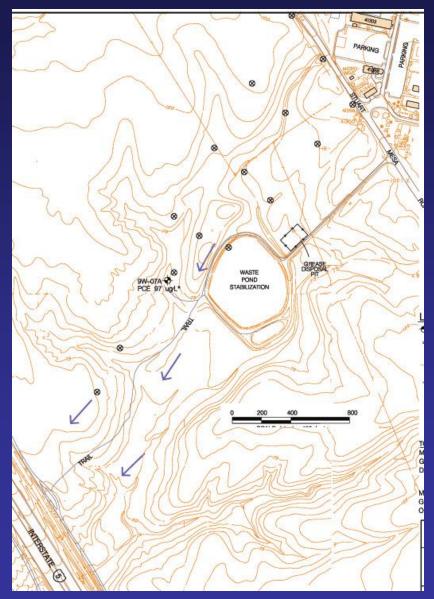
- Two areas of interest identified.
 - Tank maintenance facility in 41 Area
 - Equipment disassembly north of IR Site 9

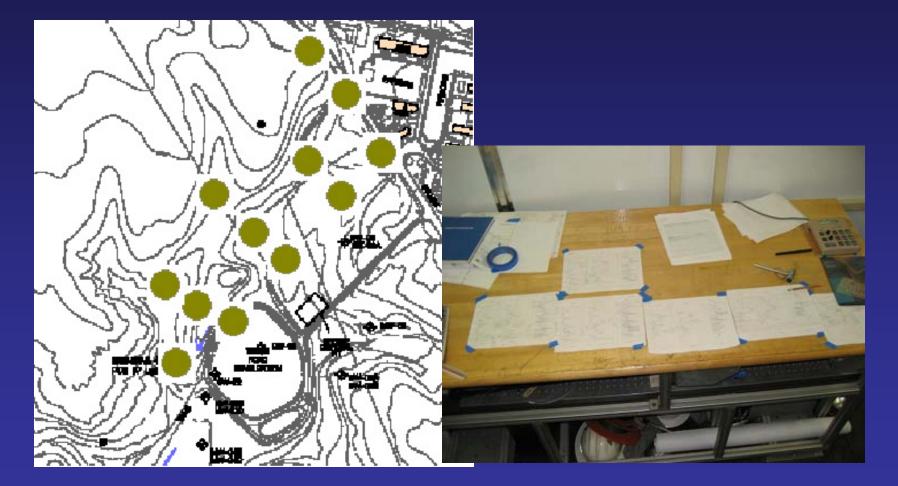
SCAPS CPT POINTS

- Three sampling transects initiated, radiating out- and upgradient from 9W-07A
- Five locations problematic: roads to 4, 14, and 15 were impassable, and shallow refusal at 1 and 3 prohibited well construction.

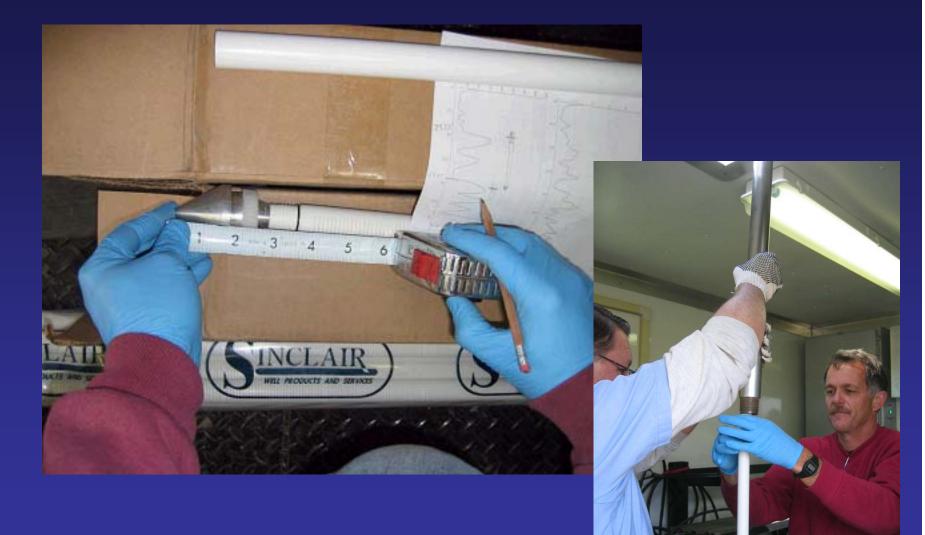
Designing Well Screen

- 12 temporary microwells constructed and sampled at 10 locations
- Each well constructed with a 5 foot screen
- Groundwater samples analyzed by HP Labs with MDL of 1.0 ug/L
- Target VOCs not detected in microwells 2, 5, 6, 7, 8, 10, 11A, 11B, and 12.
- PCE and TCE reported in 13A and 13B.

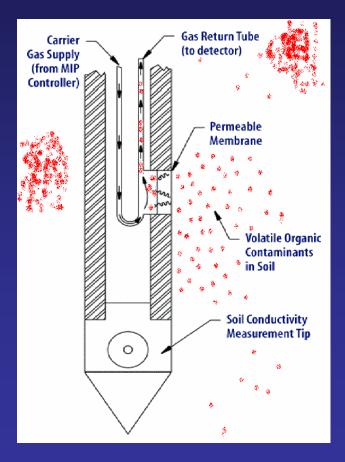
Geoprobe® Systems Membrane Interface Probe (MIP)

- An inert ultrapure helium carrier gas is sent down to the probe, sweeps behind the membrane, and returns to the surface to be analyzed.
- A temperature controller allows the membrane to be heated, which may optimize membrane performance.
- When the membrane is heated, VOCs advect away from the membrane. However, some of the VOCs pass through the membrane and are brought to the surface with the carrier gas to be analyzed.
- SCAPS analyzes the gas stream with a Direct Sample Ion Trap Mass Spectrometer (DSITMS)

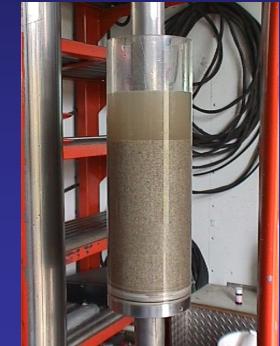
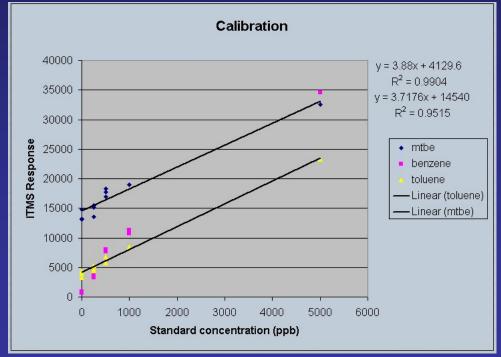
Calibrating the system.

- Samples of water containing a known concentration of contaminant are added to sand in a calibration jig and measured with the MIP/DSITMS.
- The results are used to prepare a calibration curve.

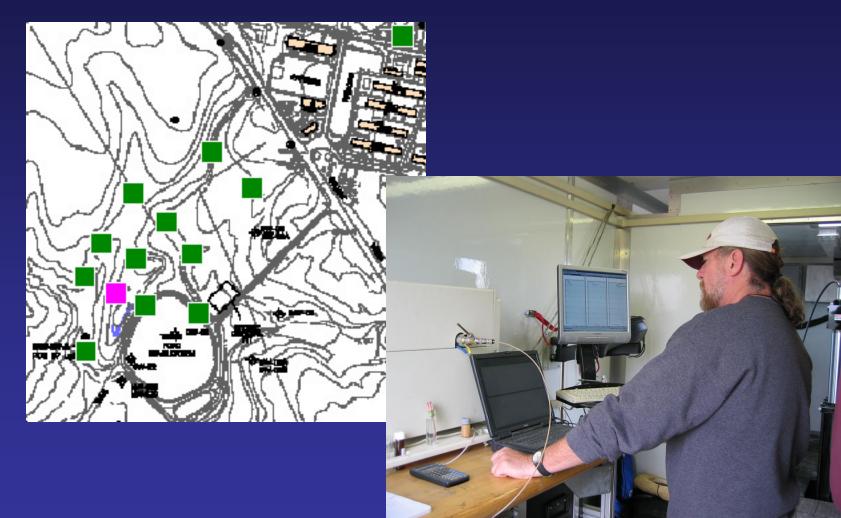
MIP Results

- Thirteen SCAPS/MIP borings advanced
- 12 sample locations positioned along three transects upgradient from 9W-07A, southwest of Stuart Mesa Road
- 1 location northeast of Stuart Mesa Road near former tank maintenance facility by Bldg. 41312

- Over 690 linear feet of site area assessed for VOCs
- MIP-11 was the single location where target VOCs were detected
