North River RRS Conceptual Site Model Presentation

U.S. AIR FORCE
NORTH RIVER RADIO RELAY STATION - SITE INVESTIGATION REPORT
**PROJECT LOCATION AND
VICINITY MAPS**

MWH
Anchorage, Alaska

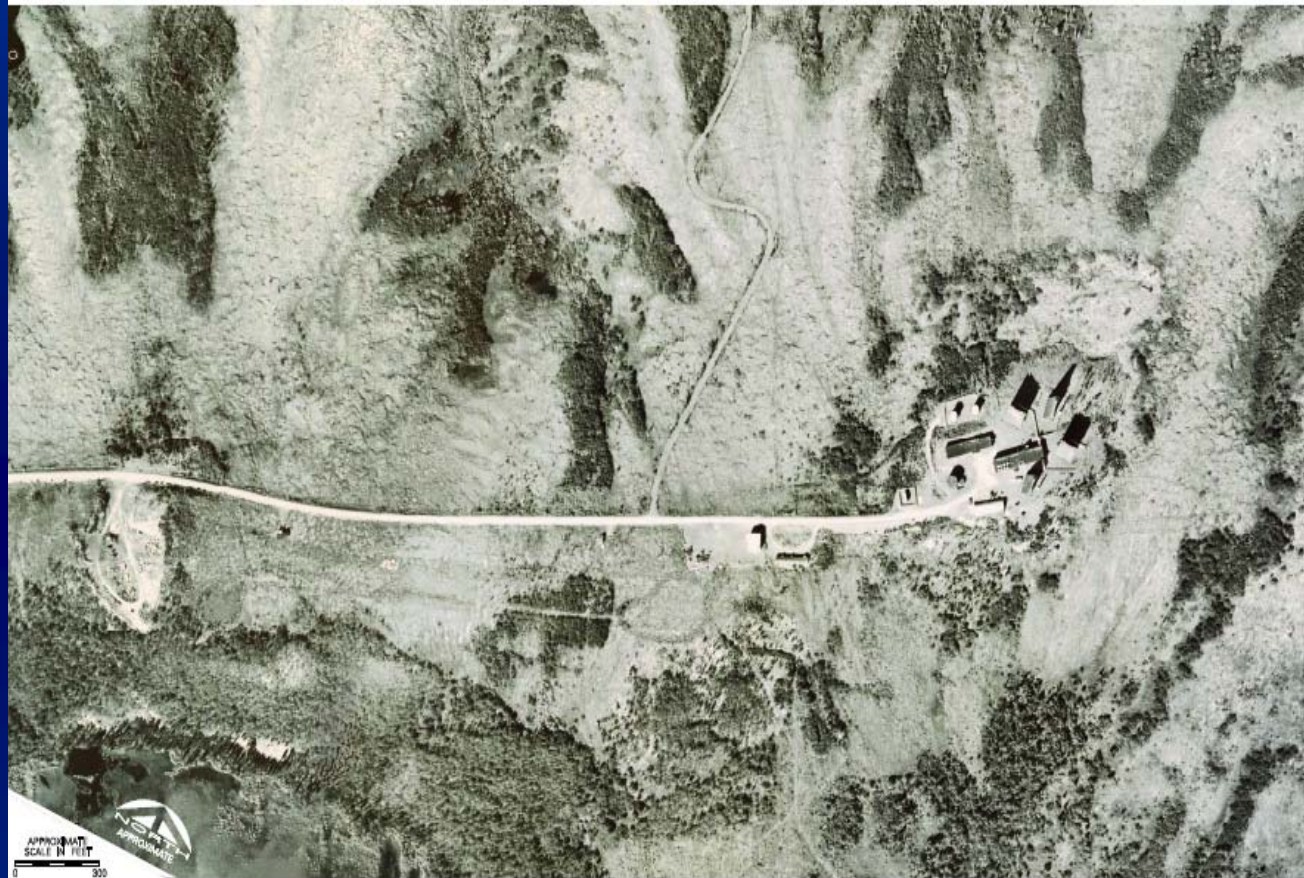
FIGURE
U.S. AIR FORCE
NORTON RIVER RADAR RELAY STATION
AERIAL PHOTO - 1974

- Constructed between 1956 and 1957 as a White Alice Communications System (WACS)
- Operated until 1978
- Site consisted of 2 barracks, generator building, warehouse, upper and lower pumphouses, and a maintenance building

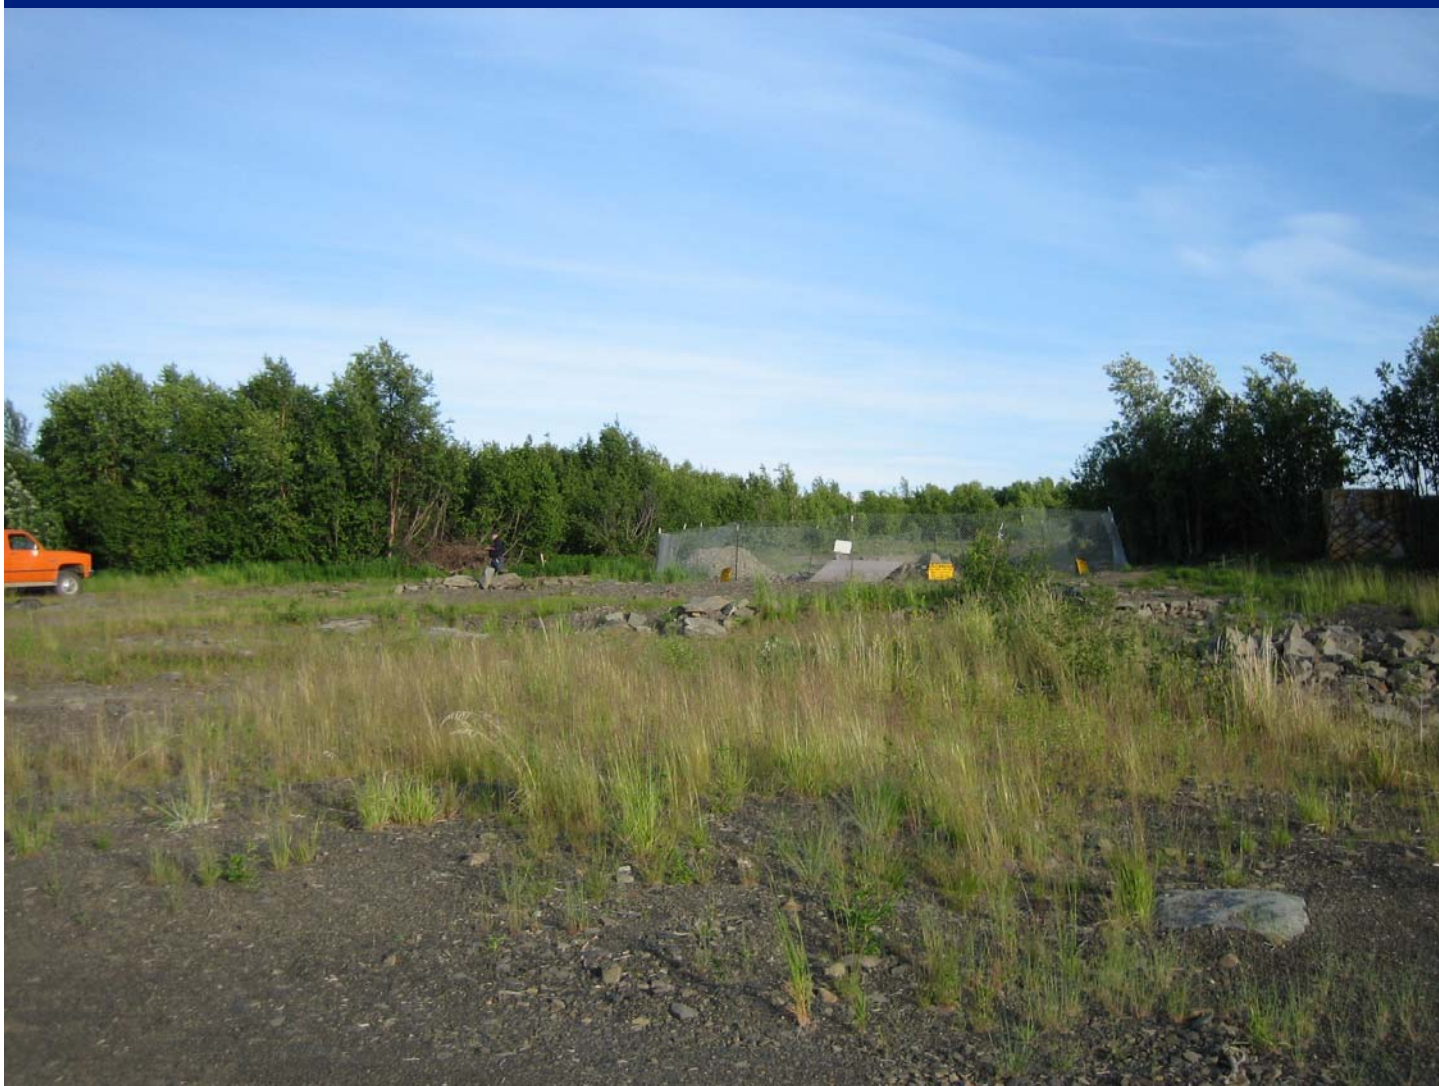
Area C

- Found by a resident in 2003
- TCRA with cleanup goal of 1 ppm for PCBs
- PCB contamination above 800 mg/kg remain
- DRO at 4,560 mg/kg also present

- Soil samples collected every 50 feet within 20 feet of centerline of roads/trails –ran using on-site laboratory
- Vegetation samples taken along the road – fixed laboratory
- Initial removal in two phases
 - 2003 – 17 tons removed
 - 2004 – 630 tons removed
- Approx 75 tons left in place since at depth of six feet (geotextile placed under backfill)
- 45 tons (35) of stockpiled soils remained in place in 2004
- Security fence established and soil stockpile cover

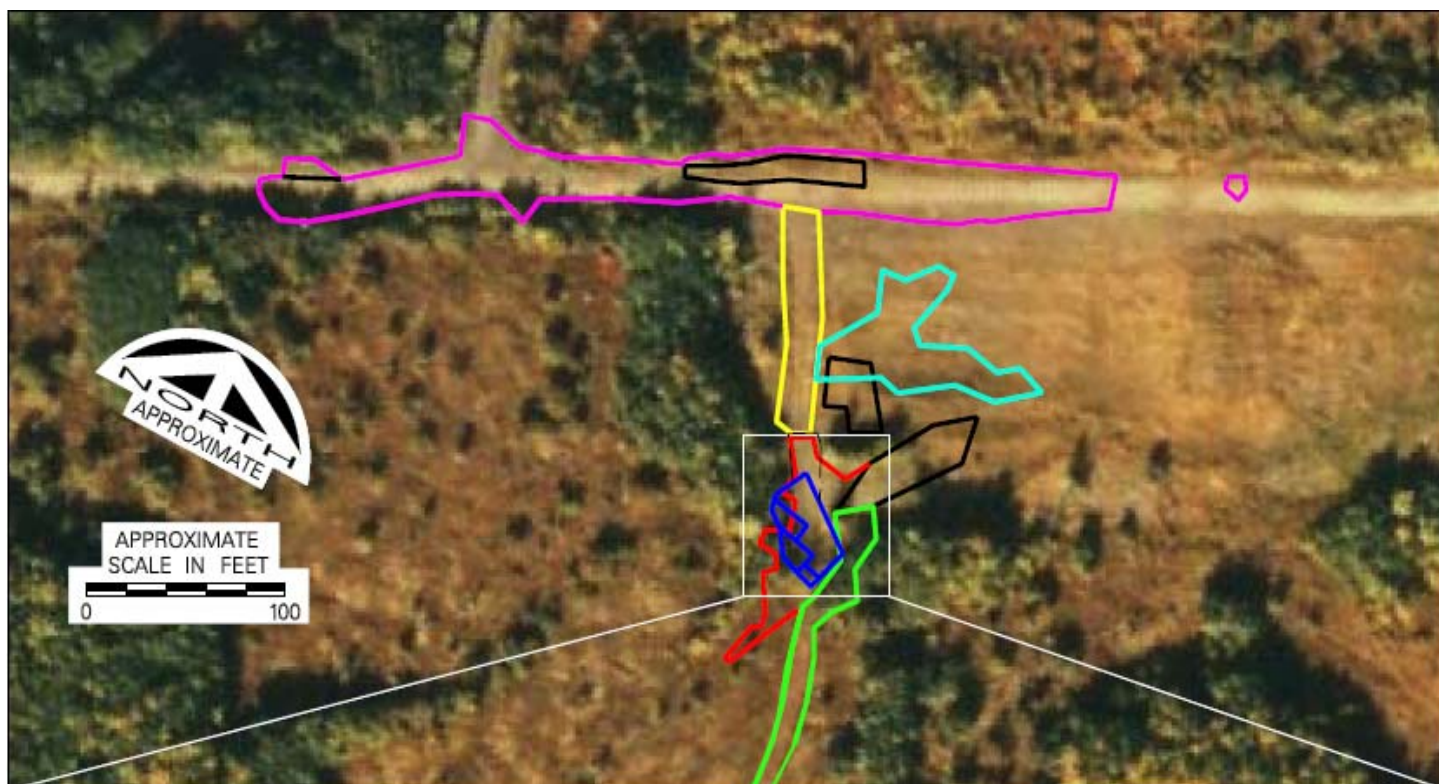
NORTH RIVER 2005 SAMPLE DATA

Sample	Location	PCB Arochlor-1260
55018058002	Surface peat in roadway	4.59
55018058003	Surface peat in roadway	5.13
55018058004	Black shale, west side excav.	0.089(U)
55018058005	Peat in excavation bank	0.514
55018058006	Clay in bottom of deep excav.	213
55018058007	Floor of road excavation	8.64
55018058008	Floor of road excavation	1.46
55018058009	Floor of road excavation	0.083
55018058010	Floor of road excavation	9.69
55018058011	Black shale, east side excav.	7.7
55018058012	Peat in pit floor	840
55018058013	Resample of redug area	0.121
55018058014	Resample of redug area	0.106
55018058015	Floor of road excavation	0.262
55018058016	Duplicate of # 15	0.054(U)
55018058017	Floor of road excavation	0.057(U)
55018058018	Floor of road excavation	9.74
55018058019	Floor of east bank	20.9
55018058020	Duplicate of # 19	1.12

Units are mg/Kg
(U) = analyte undetected

- PCB exceedences ranged from 1.46 -513 ppm
 - 1,2,4-Trichlorobenzene detected above ADEC limits in sample with highest PCB hit (003)
 - 1,2-dichlorobenze, 1,2,4-trichlorobenzene, and 1,4 dichlorobenzene detected in floor sample (008) below ADEC limits
 - DRO/RRO in floor sample (19) at 197ppm
 - Further excavation to the NE required to achieve Method 2
-
- Samples from Redig site were below ADEC Method 2

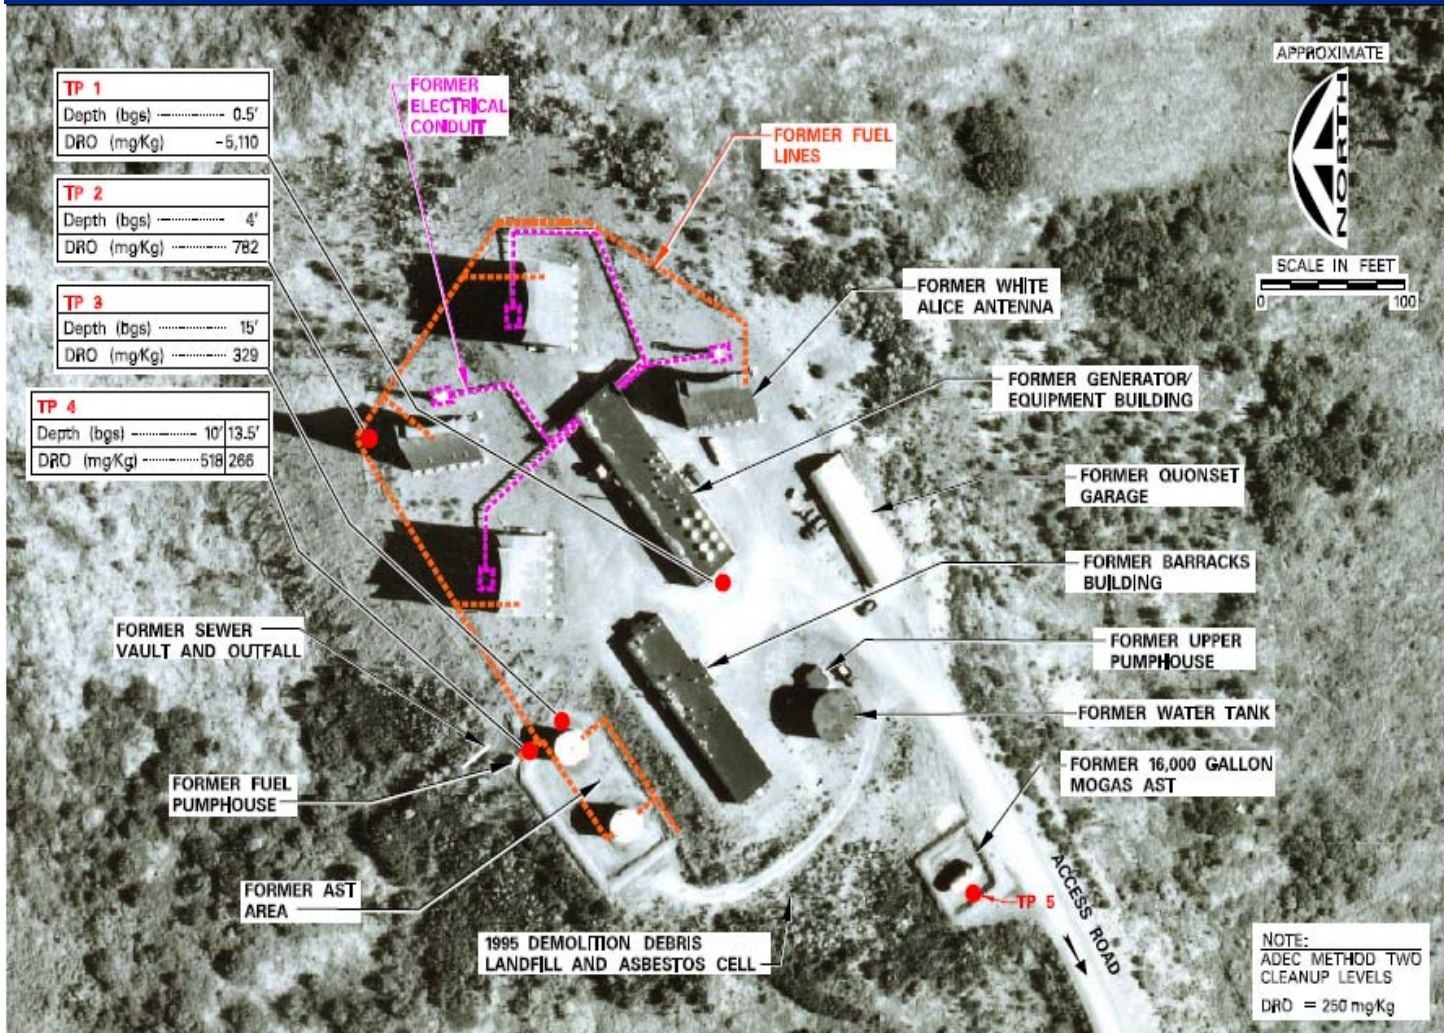
FIGURE 3-2
U.S. AIR FORCE
NORTH RIVER RADIO RELAY STATION - SITE INVESTIGATION REPORT
FORMER WACS TEST PIT LOCATIONS

Test Pit	Location	Depth	DRO in ppm
1	Generator Building	0.5 (rest clean)	5110
2	Near antenna	4.0 (rest clean)	782
3	AST storage area	15	329
4	Pump house	10	518
		13.5	266

- As: 2.56-15 ppm
- Cr: 22.9 – 49.1 ppm

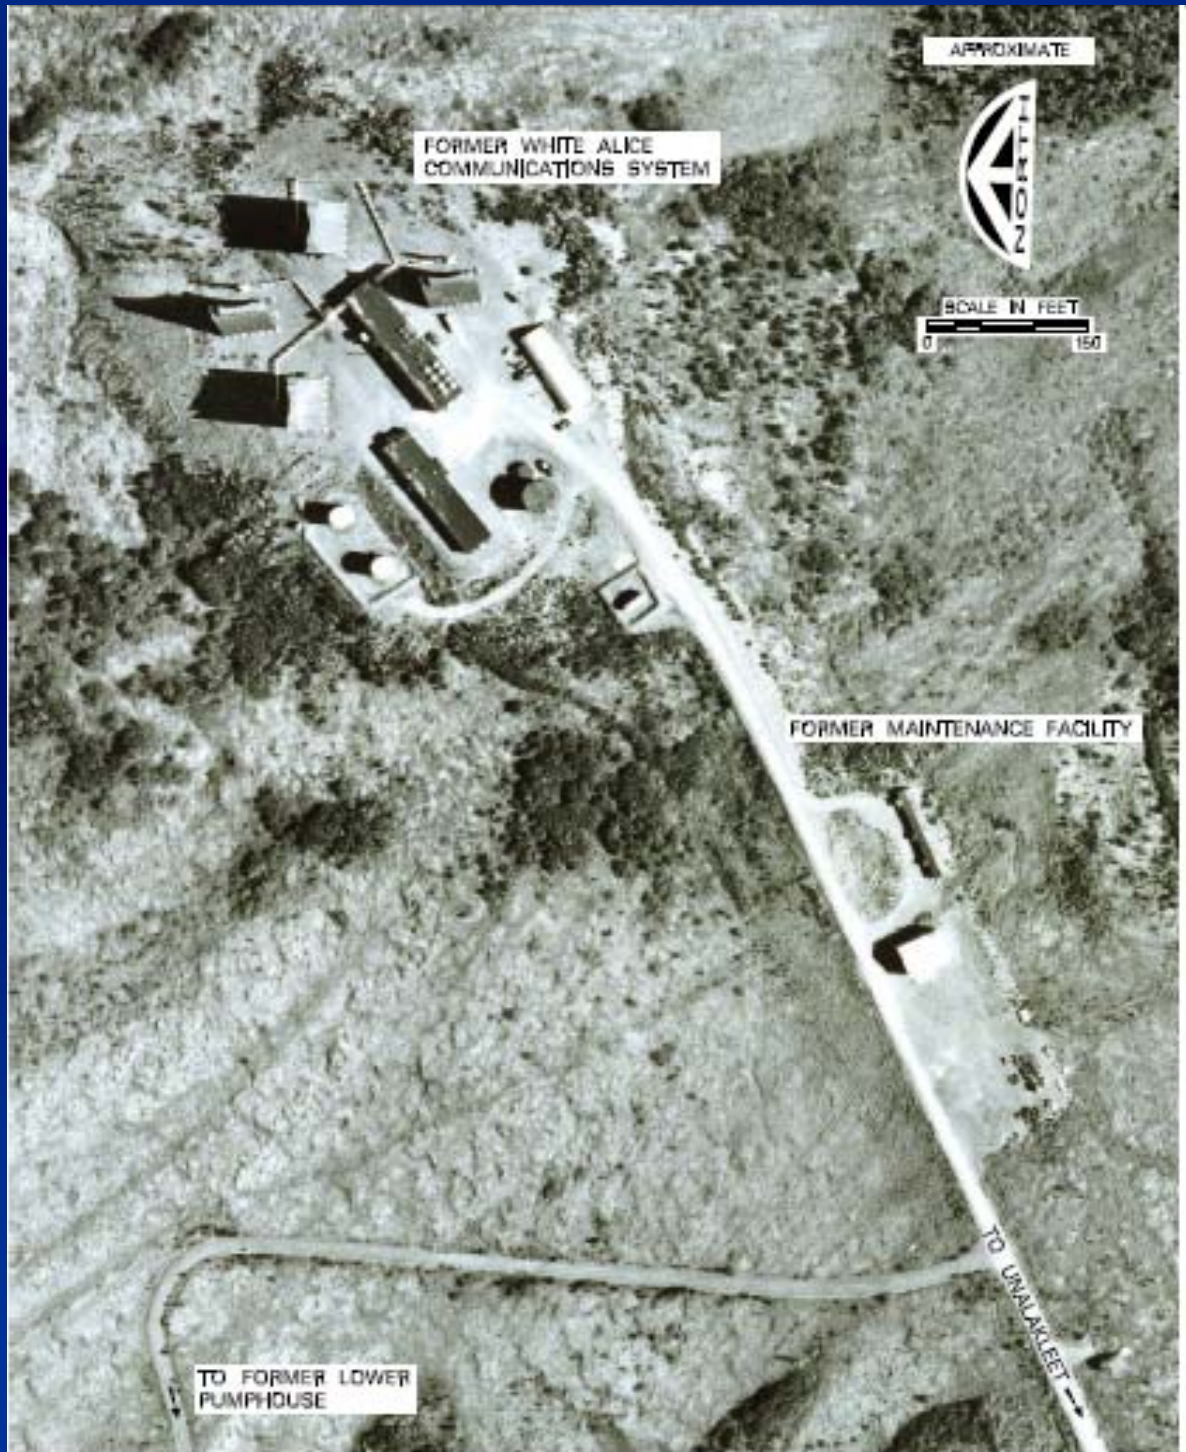
SO001 - Vehicle Maintenance Building

- 1995 - removal of 125 CY of POL soil during removal of former 500 gal UST/piping
- Confirmation samples max = 11,900 ppm DRO at 7 feet
- 2002 - 3 drums/stained soil removed – contaminated soil located near trail to resident cabin
- Additional soil sampling/TCRA discussed as Area C

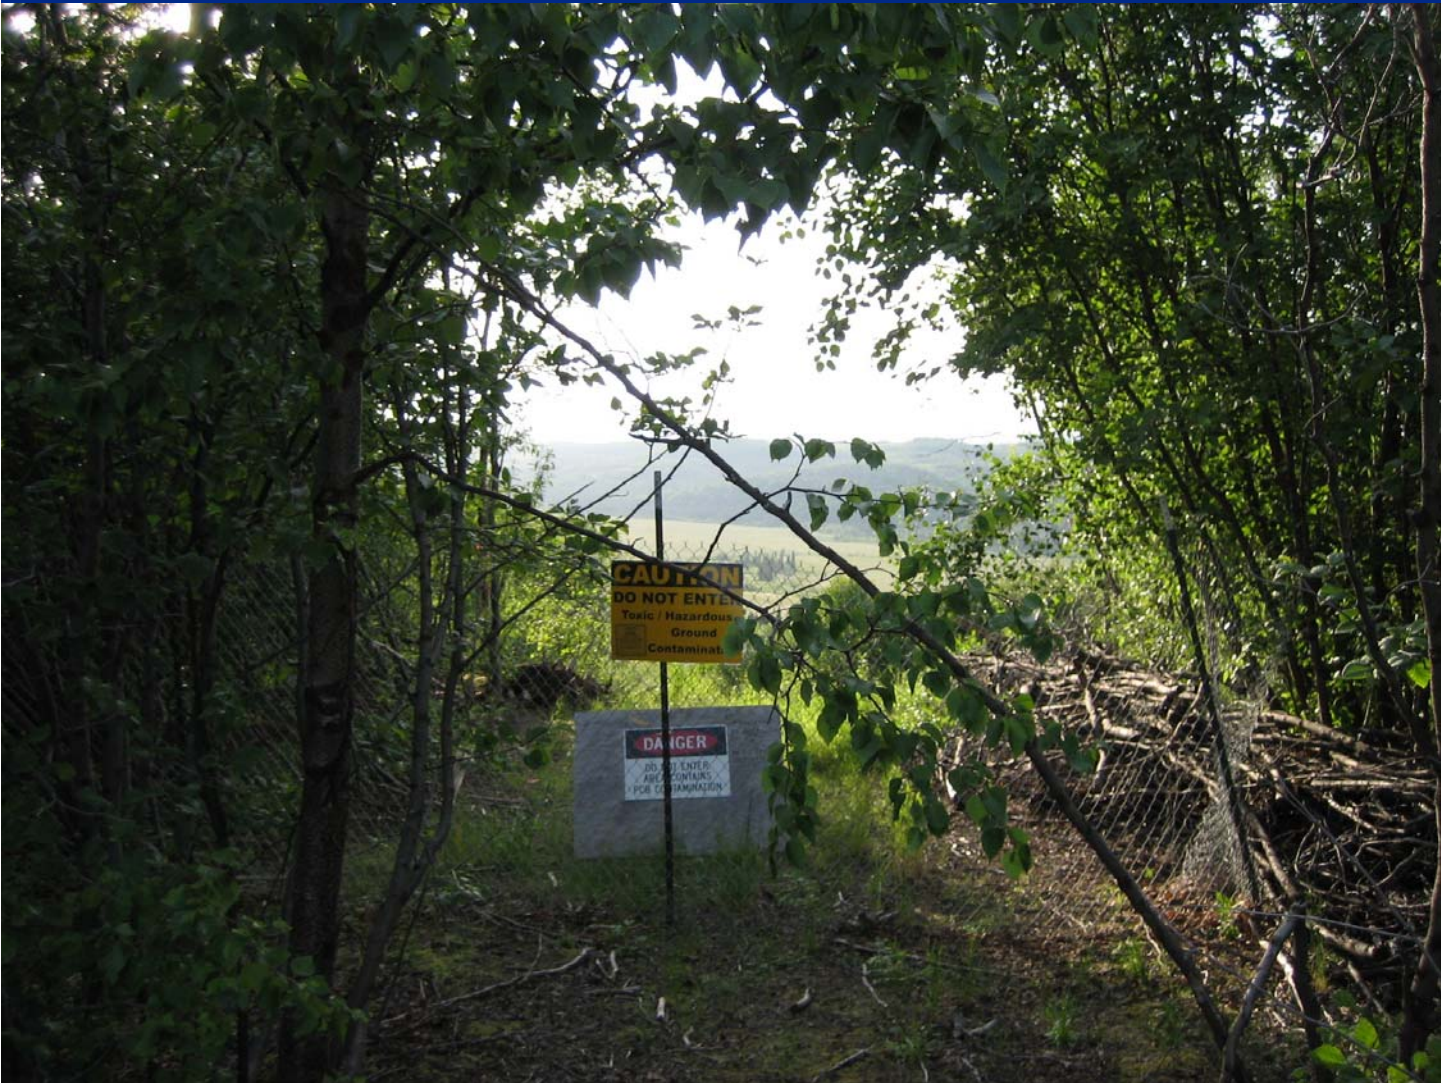
SS003 (Area A) - Drums and Stained Soil

- This site was identified in 2003 during an investigation by the USACE.
- PCBs detected at 122 mg/kg which is over the State cleanup level of 1 mg/kg
- Several drums were removed from Area A and petroleum contaminated soil was identified in association with the drums.
