**McGuire Air Force Base Restoration  
Program Site # SS-24**

***Interim Remedial Action***

**NJDEP Triad Approach Meeting September 4<sup>th</sup>, 2003**

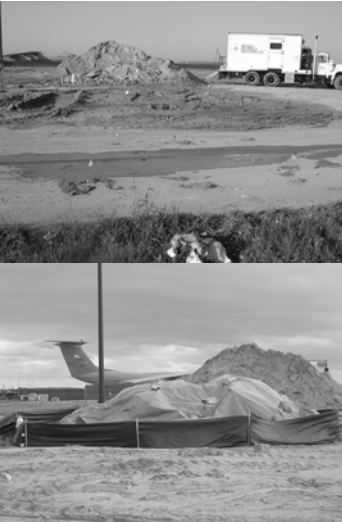
**McGuire AFB, NJ C17 Hanger Site Investigation**

**The problem:**

Construction of a new hanger for C17 aircraft delayed by recently discovered potential CI solvent source.

Very limited GW sampling indicated up to 1% of solubility limit PCE

Same data indicated limited distribution of shallow dissolved phase

Apparent dechlorination underway at site
