# Driftwood Bay RRS

## Facility History

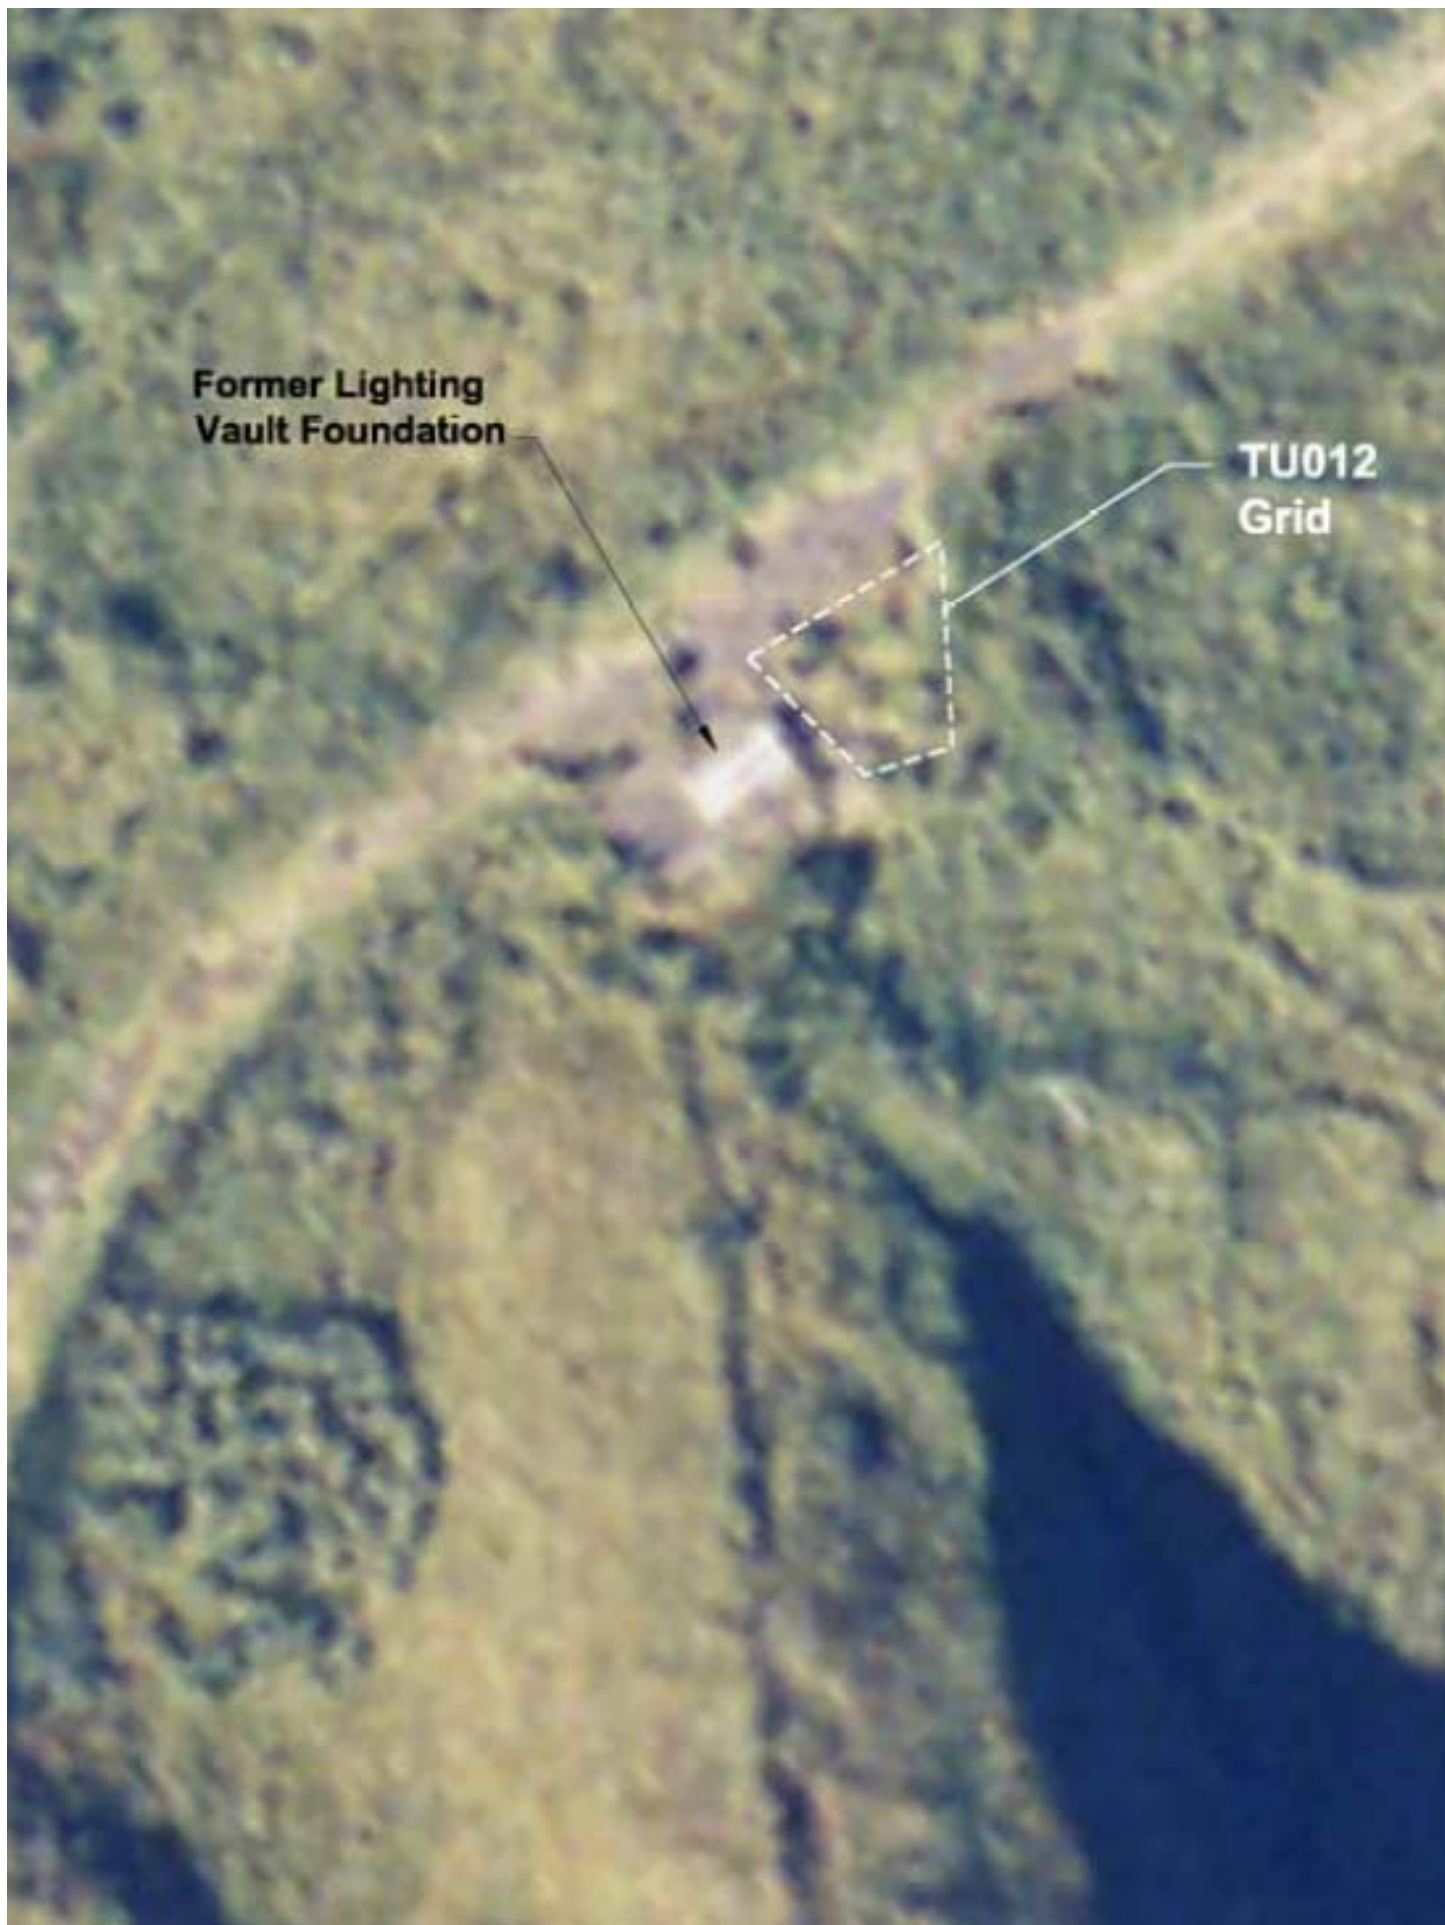
**TU012  
Grid**

- 650' southeast of southern end of runway
- USTs and contaminated soils removed in 1991
- Four soil samples collected in PA/SI and submitted for DRO/RRO, GRO, VOCs, PAHs, and metals
- No analytes detected above screening criteria. No odor or stained soil, were observed.
- Site suitable for administrative closure without further action.

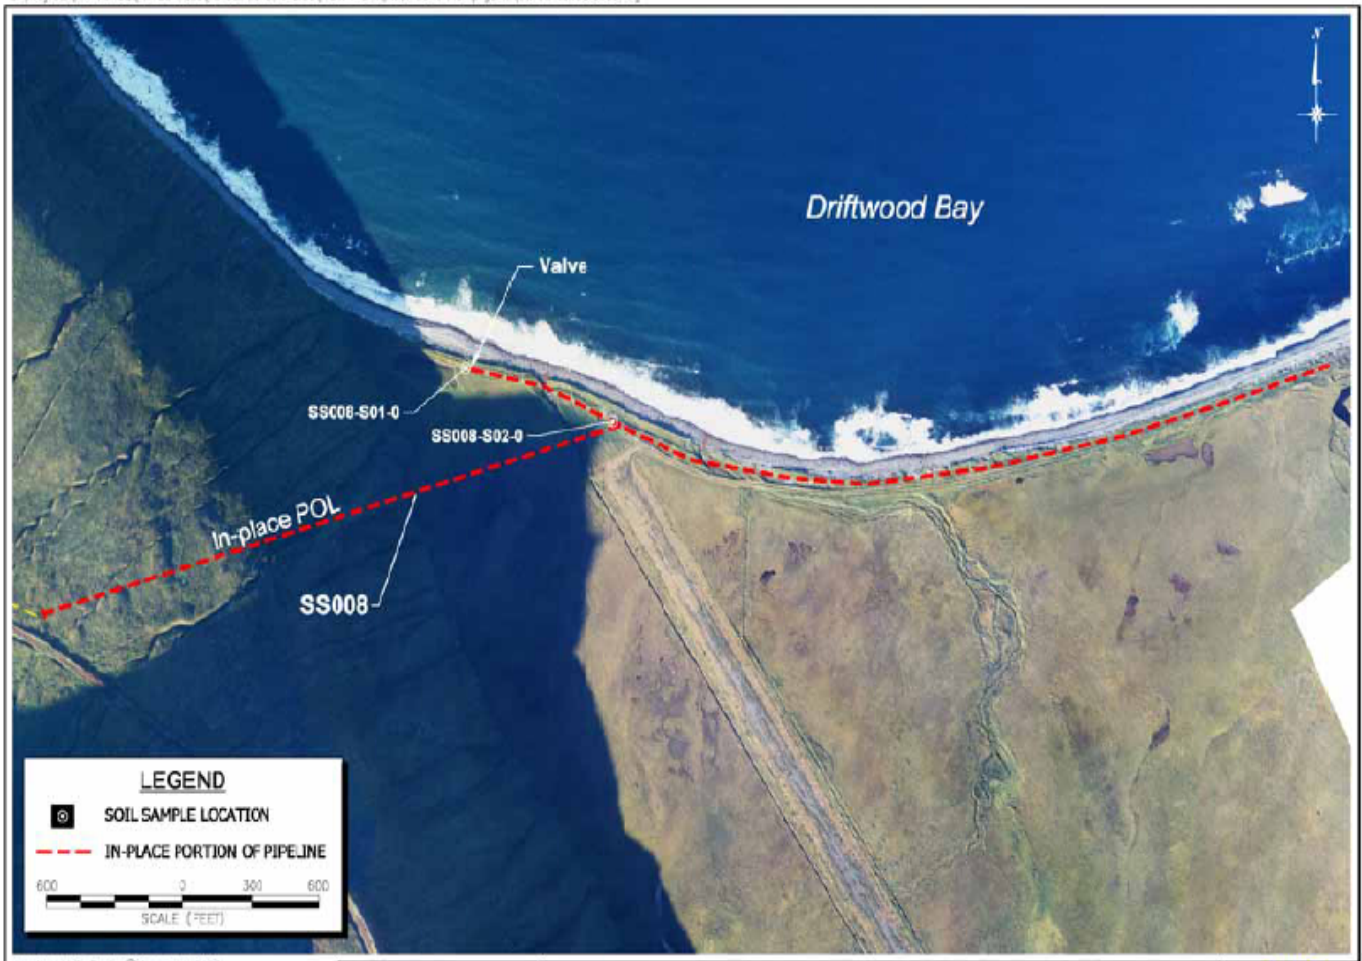
- Portions of pipe found in place along beach and west of beach. No residual produce observed
- Fill stand found
- No evidence of stressed vegetation along corridor
- Only two PID hits noted along beach
  - Under fill stand (3.1 ppmv)
  - 700' east of fill stand (28.2 ppmv)

Sample	Location	DRO
SS008-S01	Fill stand (1.5' bgs)	111
SS008-S02	700' E of fill stand (1.5'bgs)	9,600

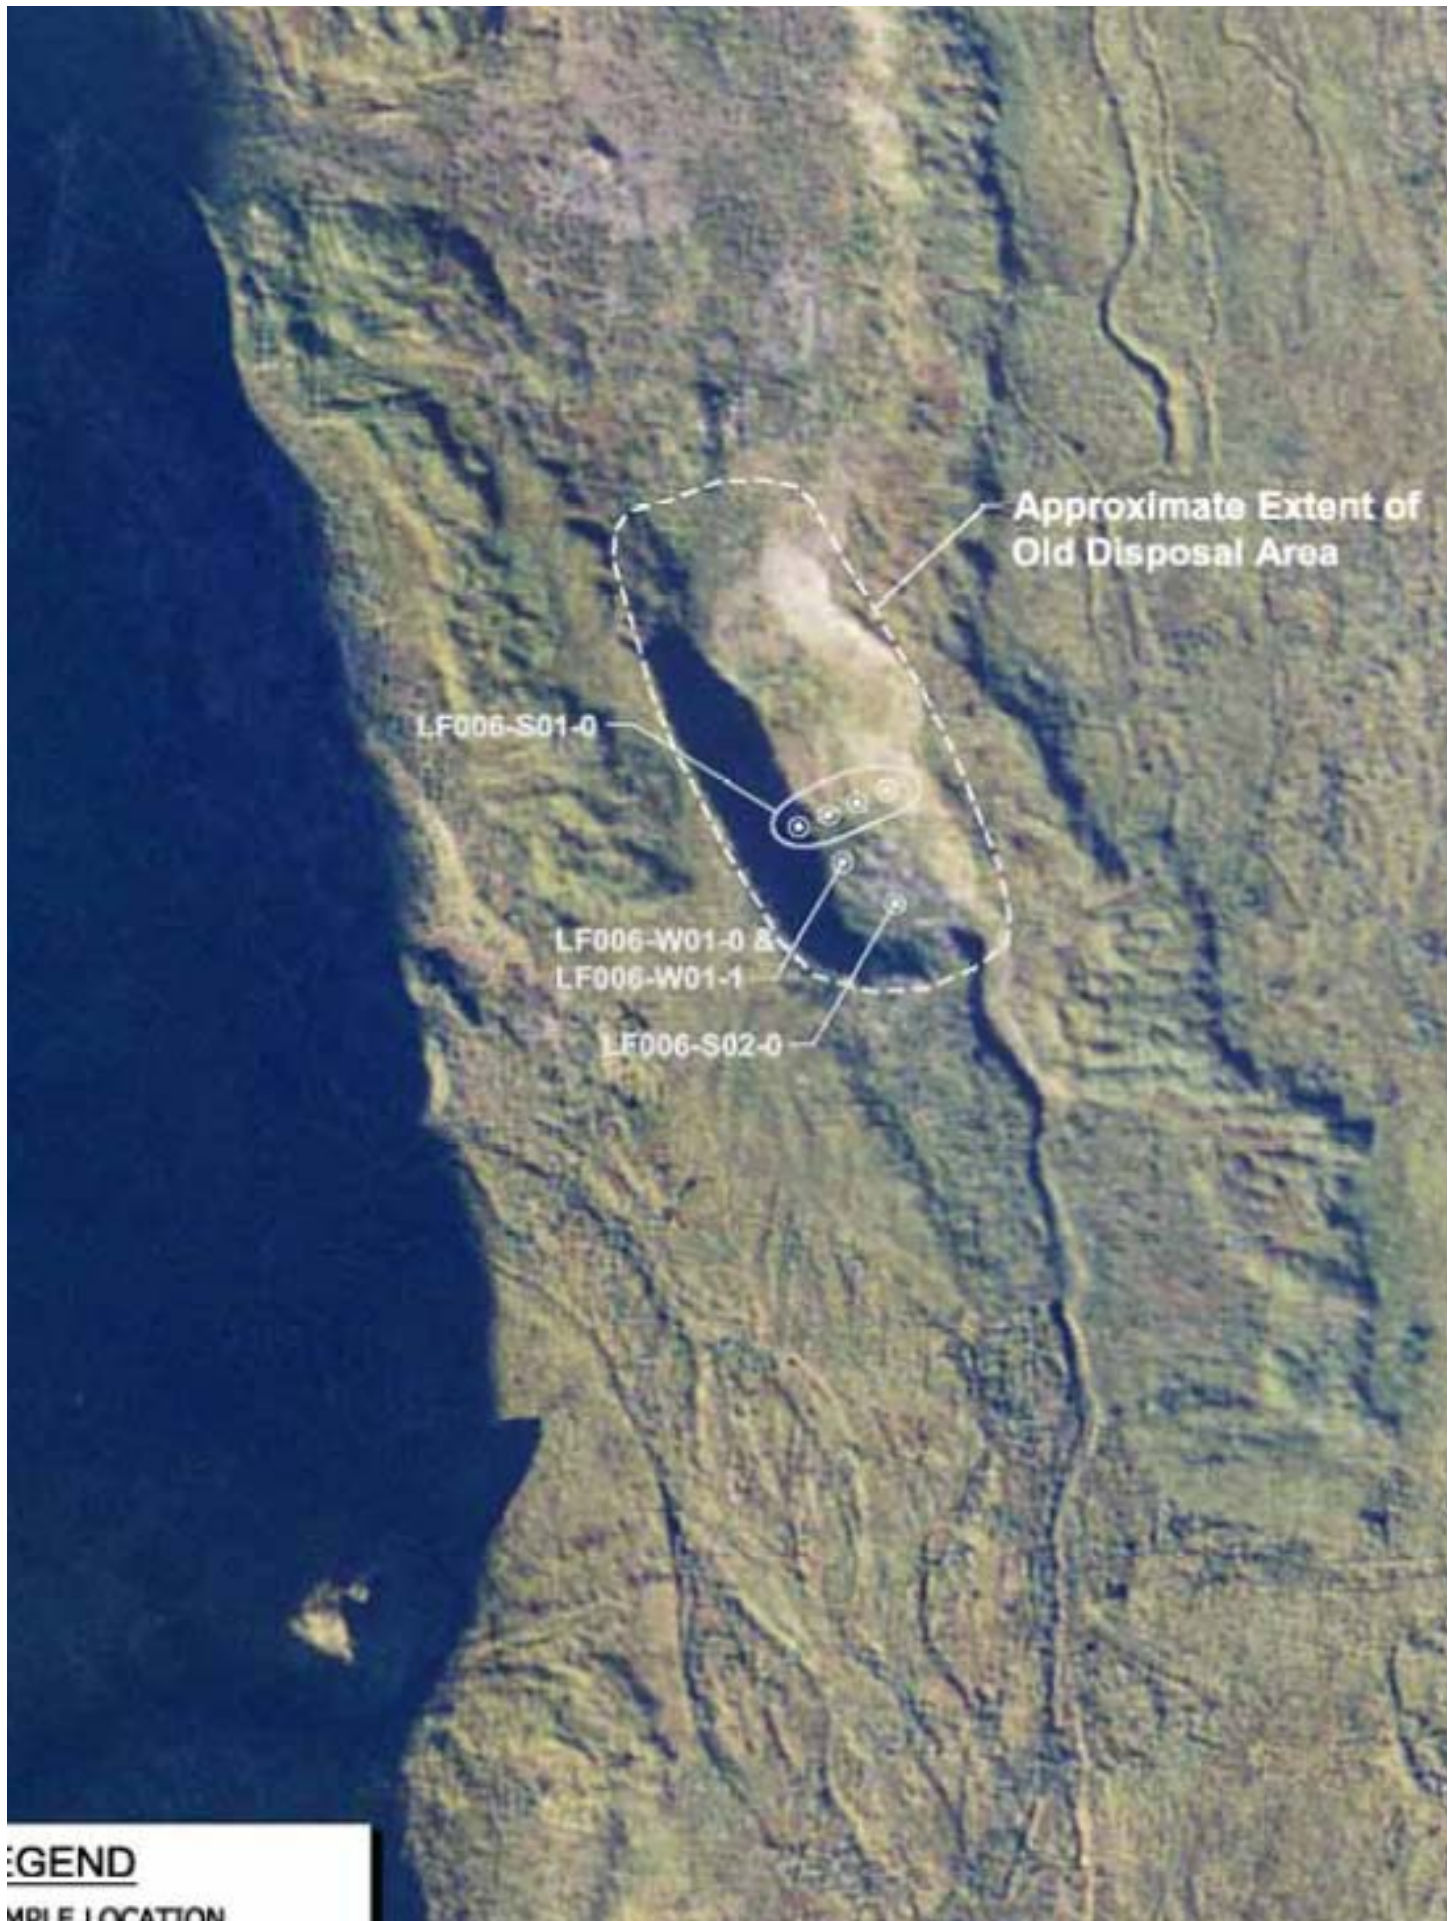
- 18 55-gallons drums observed from air
- Appeared to be a borrow pit used as a Landfill (200' x 75', 20' deep)
- Small pond contained submerged drums
- Exposed debris included engine, vehicle parts, batteries, fire extinguisher
- No stressed vegetation, or sheen on water observed
